GOLD RIVER MULTI- USE BRIDGE

GOLD RIVER, NOVA SCOTIA

CONDITION ASSESSMENT REPORT

September 26, 2021 (REVISION No. 1)

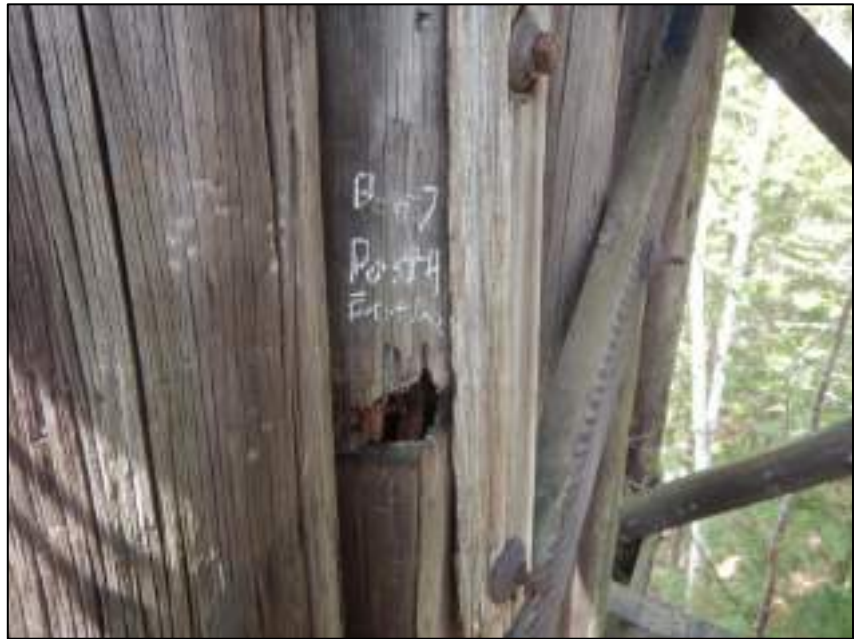
Photo 1:

- a) Several timber pilings were observed to have animal/insect holes and local areas of decay. At some of the piles the outer layers/growth rings have delaminated and/or there is significant spitting at the timber surface. At most piles that deterioration may not penetrate deeply into the heartwood. See Photos 1-5.
- b) Decay is advancing at sawn ends of several cross-bracing members. This deterioration appears to be extending into areas where bolted connections are located, bringing the integrity of those connections into question. See Photos 6-10.
- c) Areas of damage resulting from vandalism were observed. Photos 11-12.
- d) Several steel fasteners and related connecting hardware were observed to be heavily corroded and in need of replacement. Photos 13-16

East approach bent 6 post 4.
Animal/insect damage.

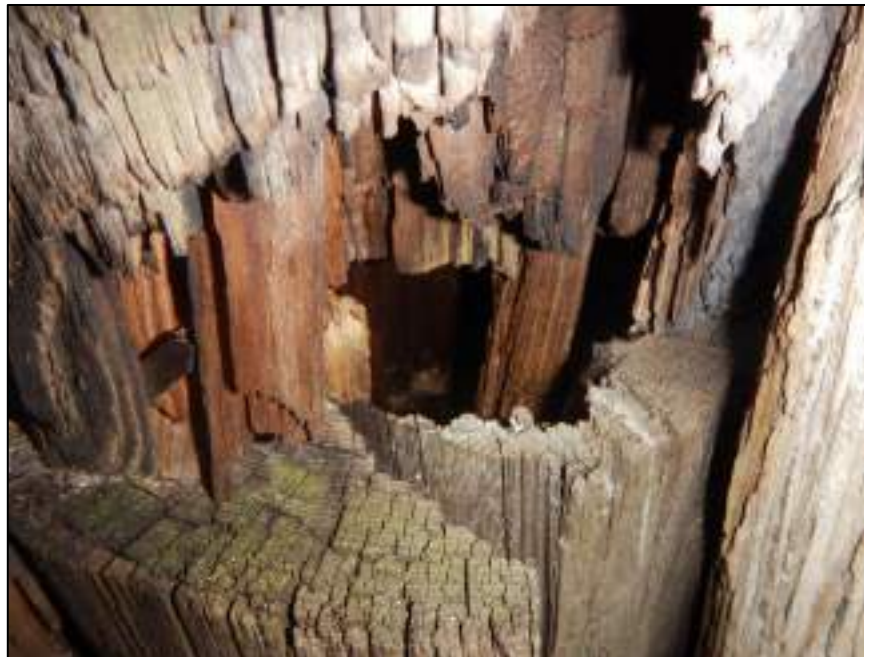
Photo 2:

Close up of previous photo.

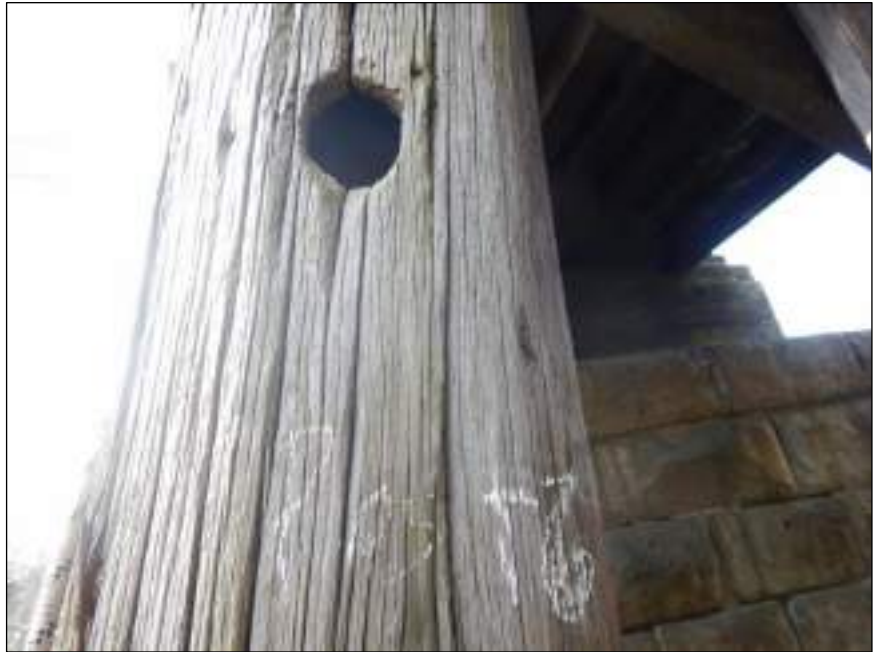
Photo 3:

East approach bent 6 post 6.
Animal/insect damage.

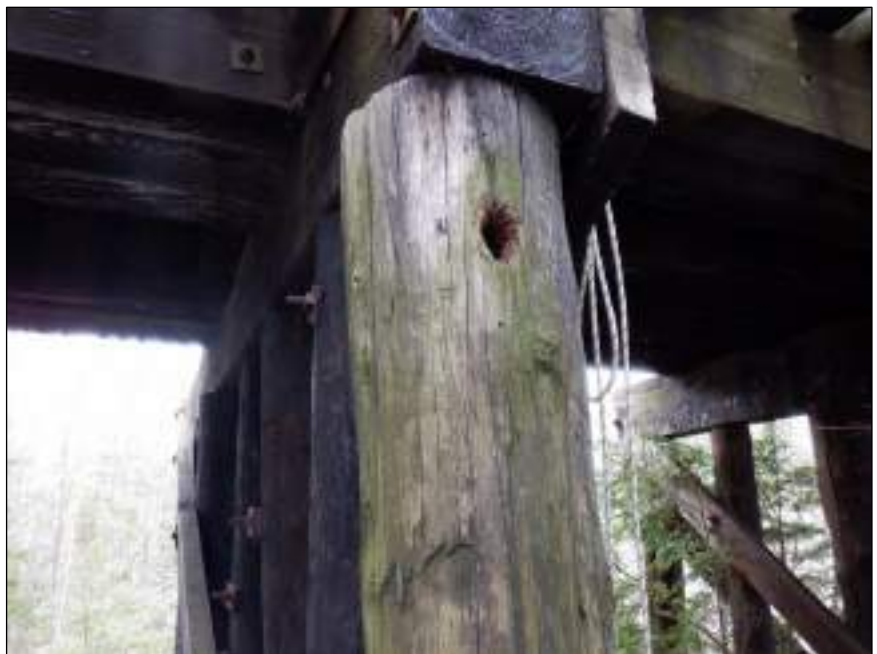
Photo 4:

East approach bent 3 post 1.
Animal/insect damage.

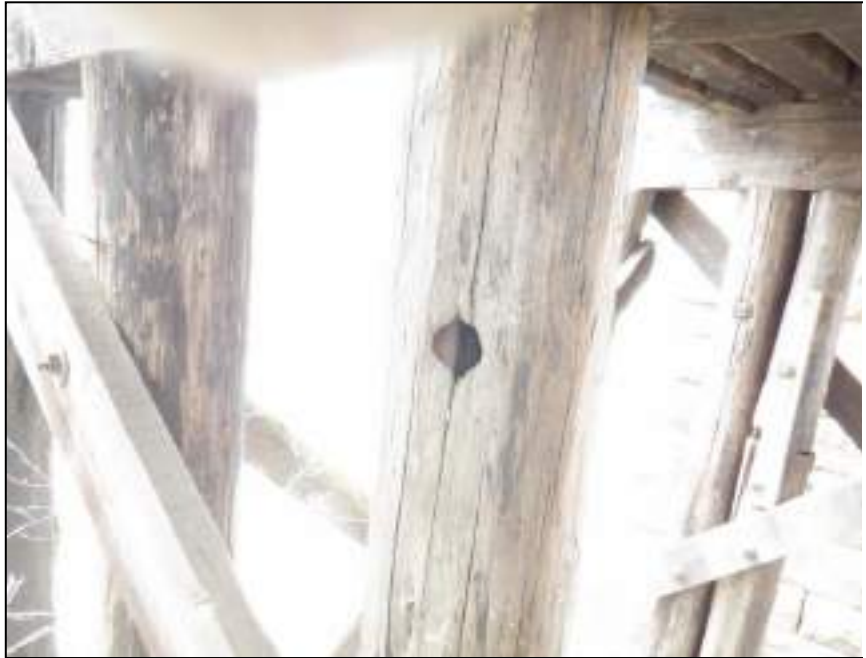
Photo 5:

East approach bent 6 post 3.
Animal/insect damage.

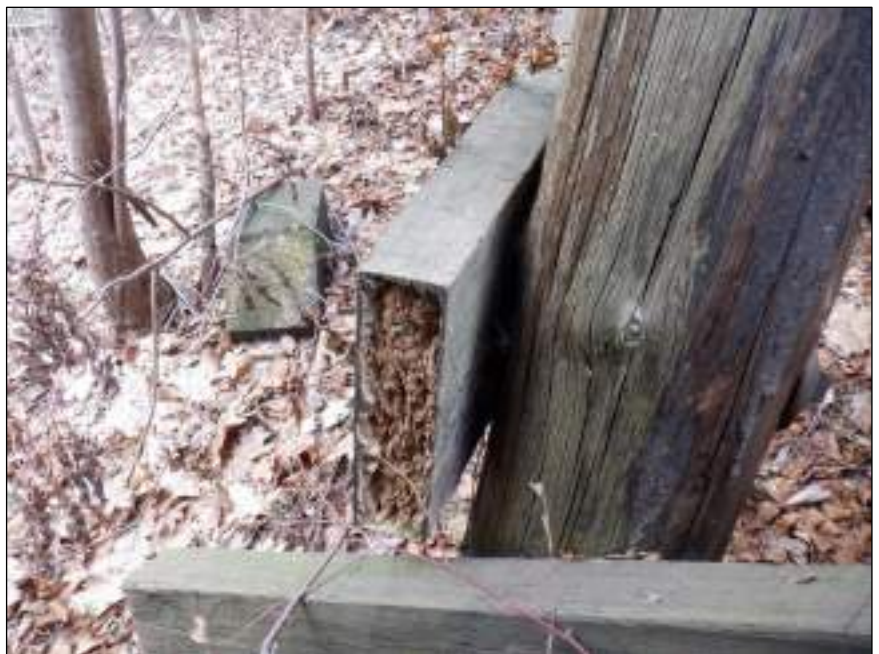
Photo 6:

East approach bent 6 post 1. Bracing
end decay.

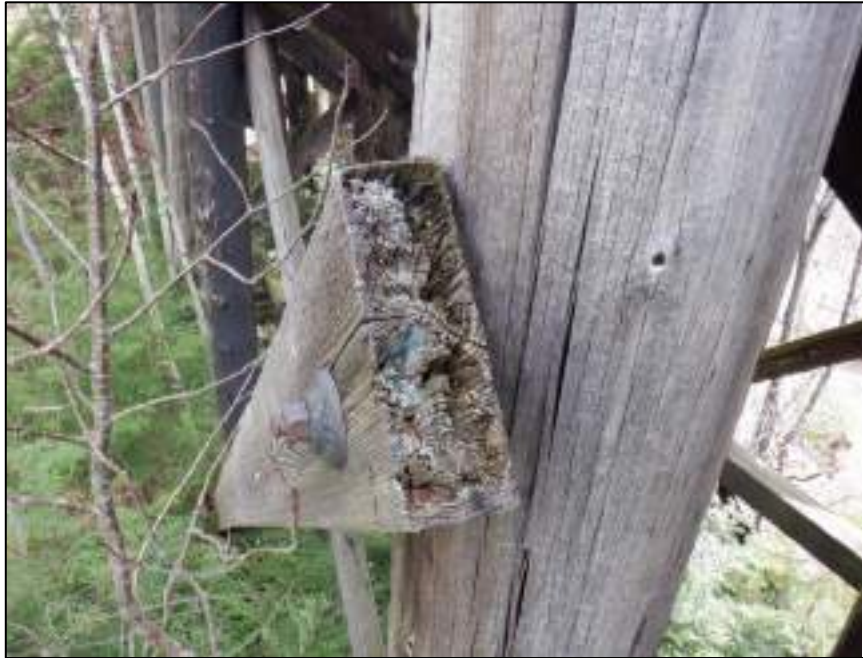
Photo 7:

East approach bent 7 post 1. Bracing
end decay.

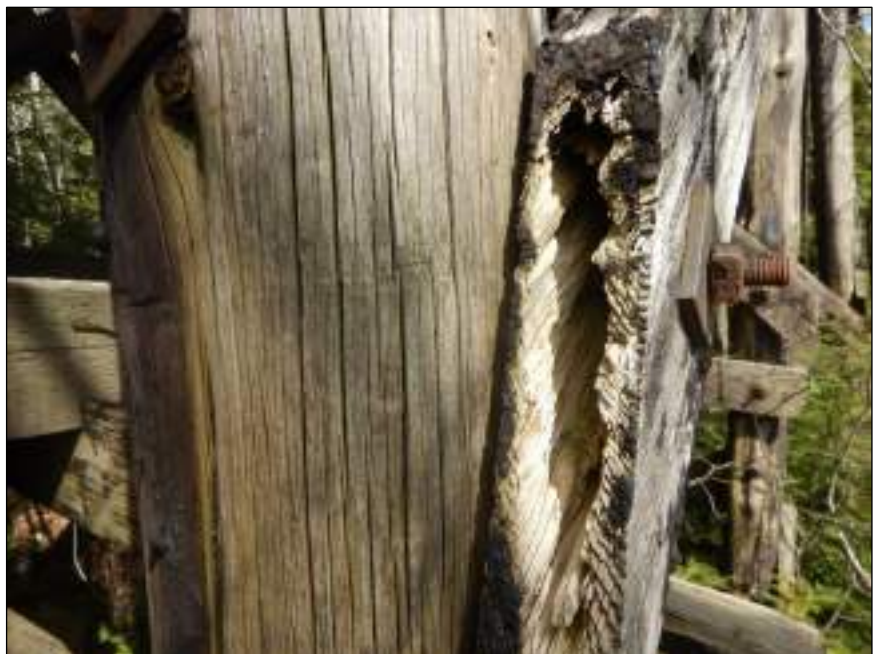
Photo 8:

East approach bent 6 post 6. Bracing
end decay.

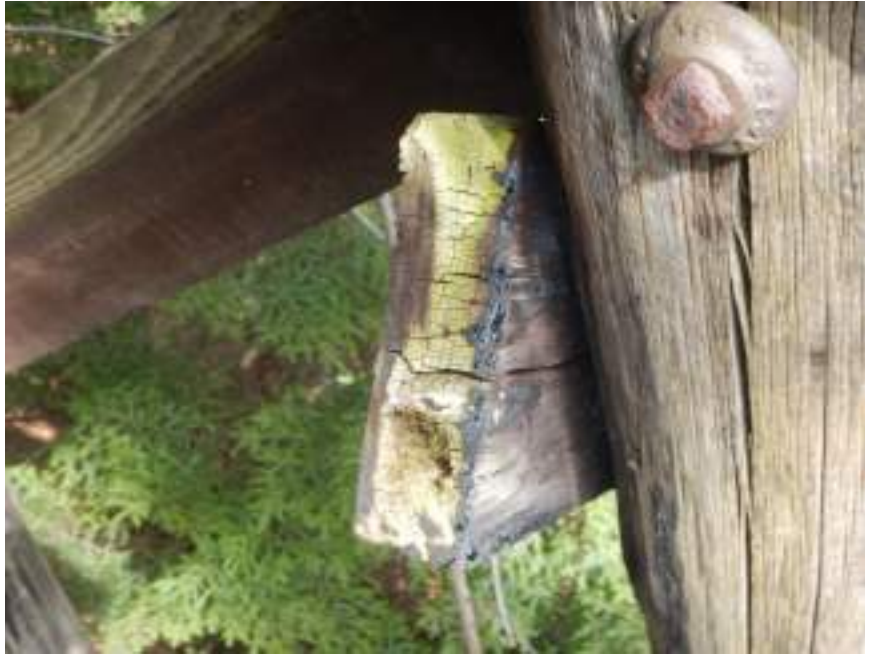
Photo 9:

East approach bent 6 post 6. Bracing end decay.

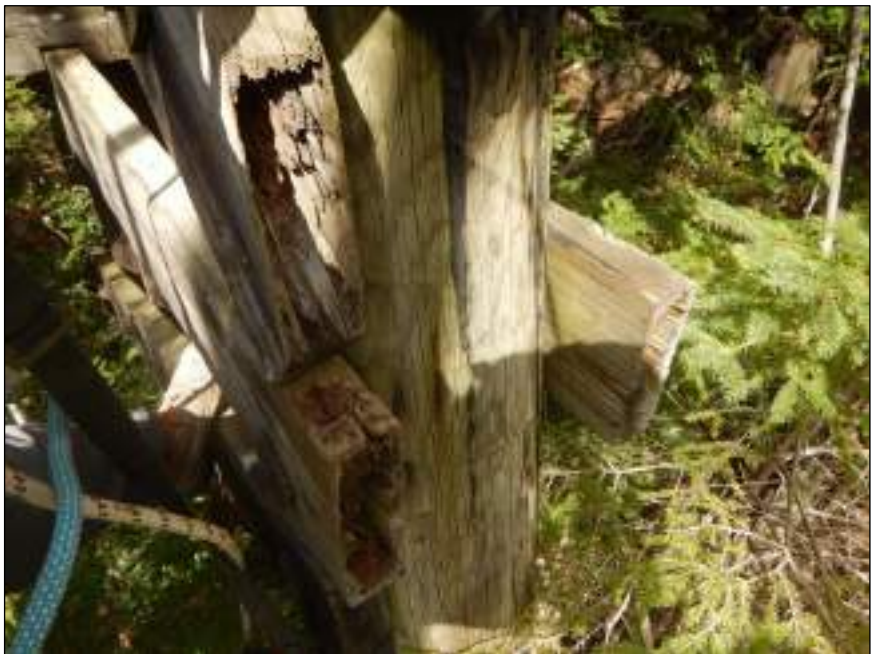
Photo 10:

East approach bent 6 post 6. Bracing end decay.

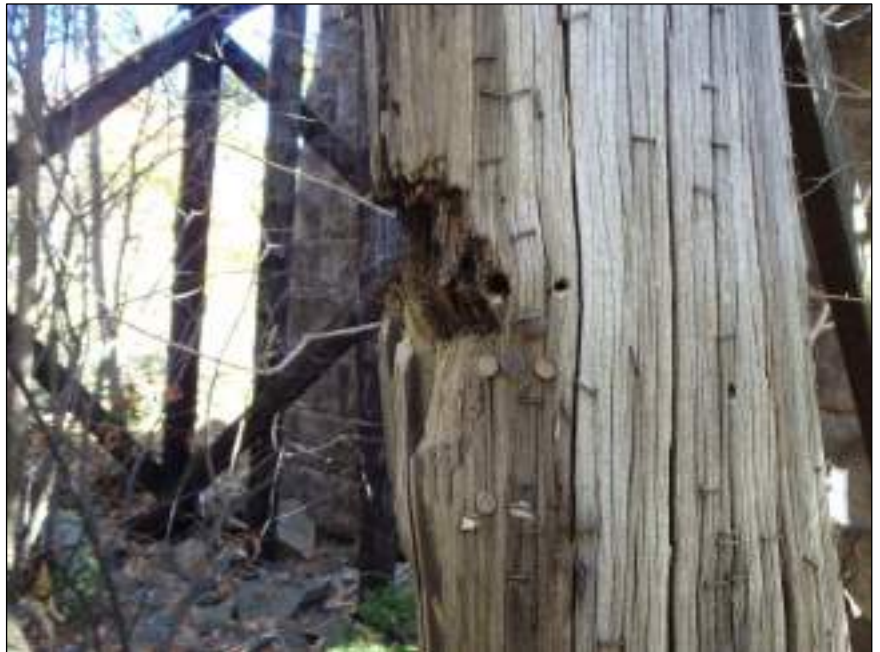
Photo 12:

West approach bent 11 post 6.
Vandalism.

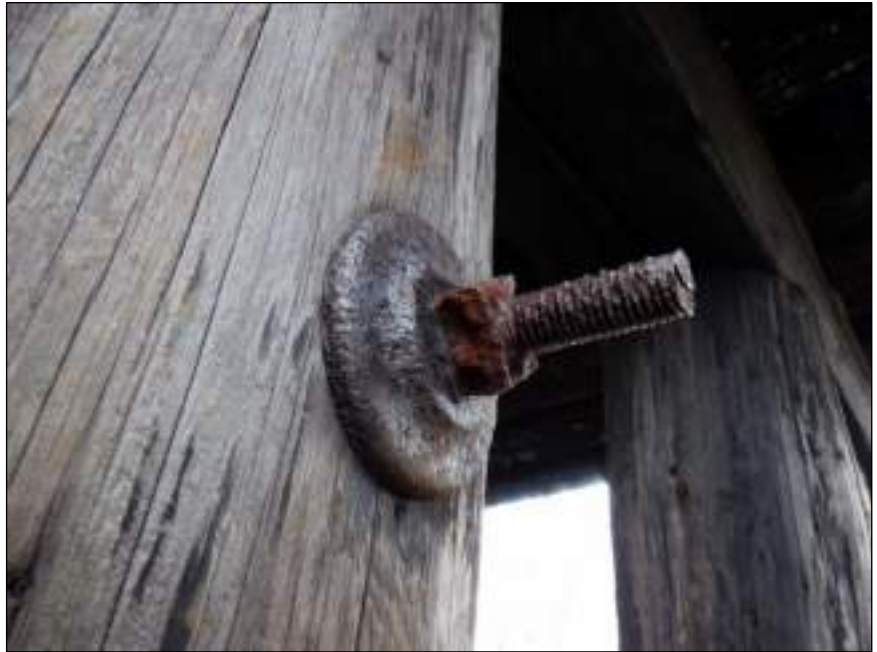
Photo 13:

East approach North side. Heavily corroded and deteriorating nut.

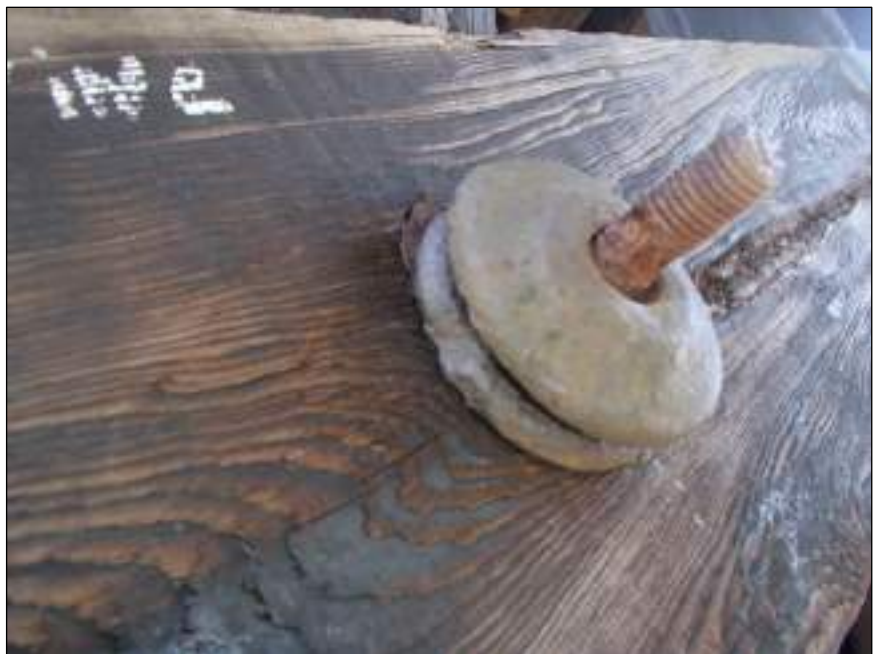
Photo 14:

West approach bent 9 post 4. Missing nut.

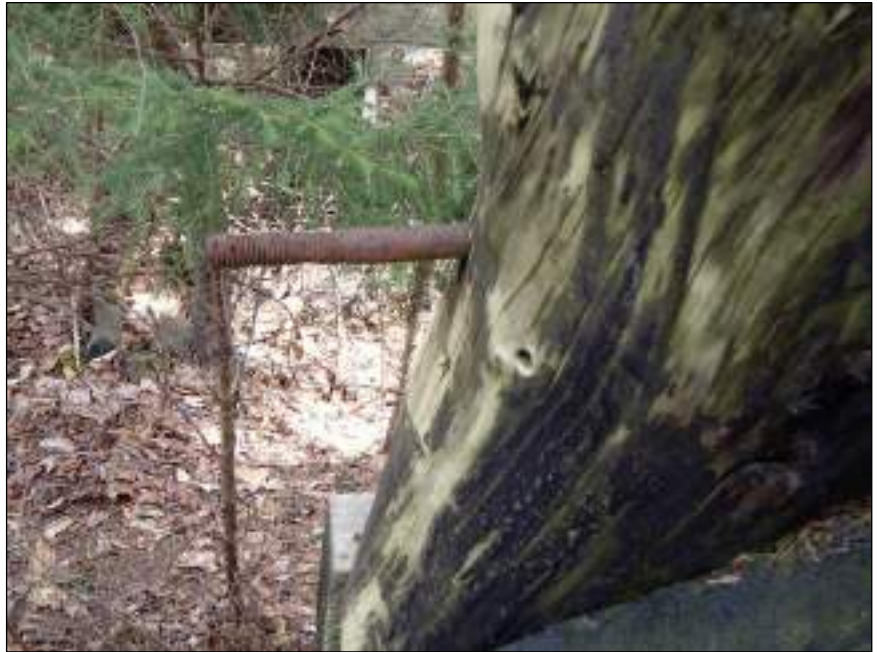
Photo 15:

West approach bent 3 post 1. Missing nut.

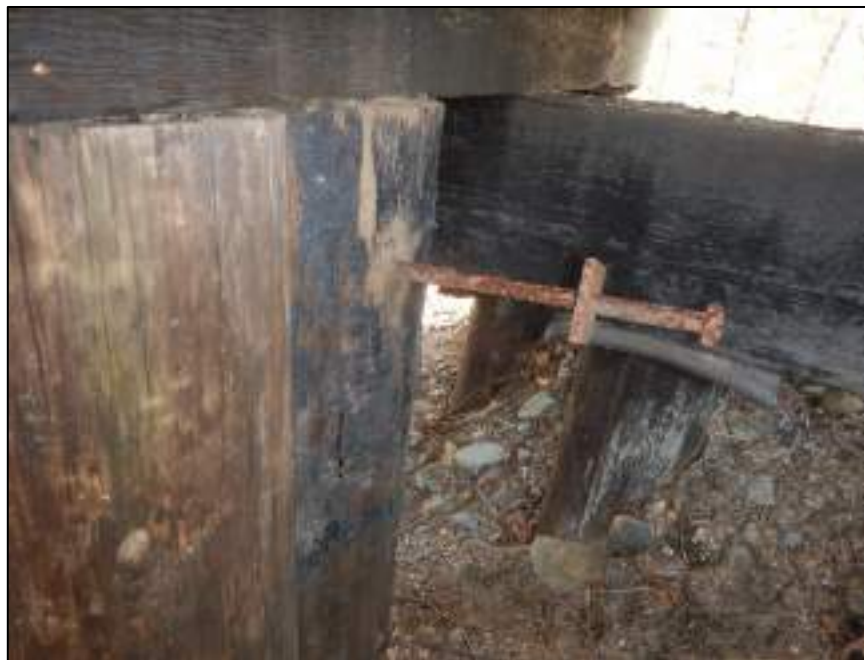
Photo 16:

West approach bent 1 post 1. Loose rod.

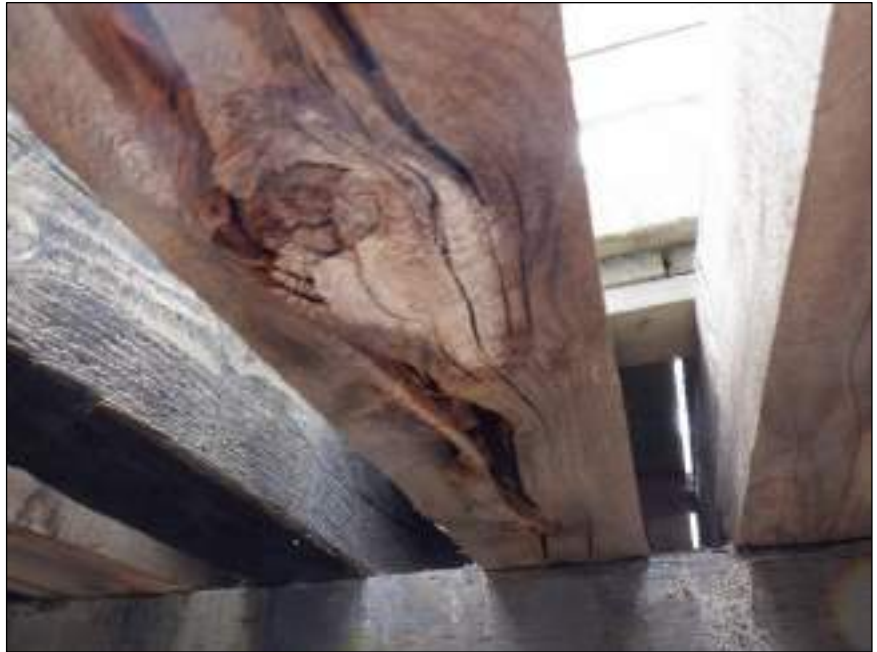
Photo 17:

- e) Some rail ties, in particular a grouping near the junction of the eastern trestle approach and the eastern steel girder span have been replaced in recent years. However, those ties were not treated with creosote and have suffered serious rot related deterioration. Those rotted ties, although appearing to have originally been treated with a chromated copper arsenate (CCA) or similar preservative solution are no longer serviceable in spite of being installed long after original construction of the bridge. Remaining original rail ties, though exhibiting some splits and some sawn end deterioration tend to be in much better condition than those recent replacements. See Photos 17-18

East approach North side near bent 4.
Newer style rail tie is decaying.

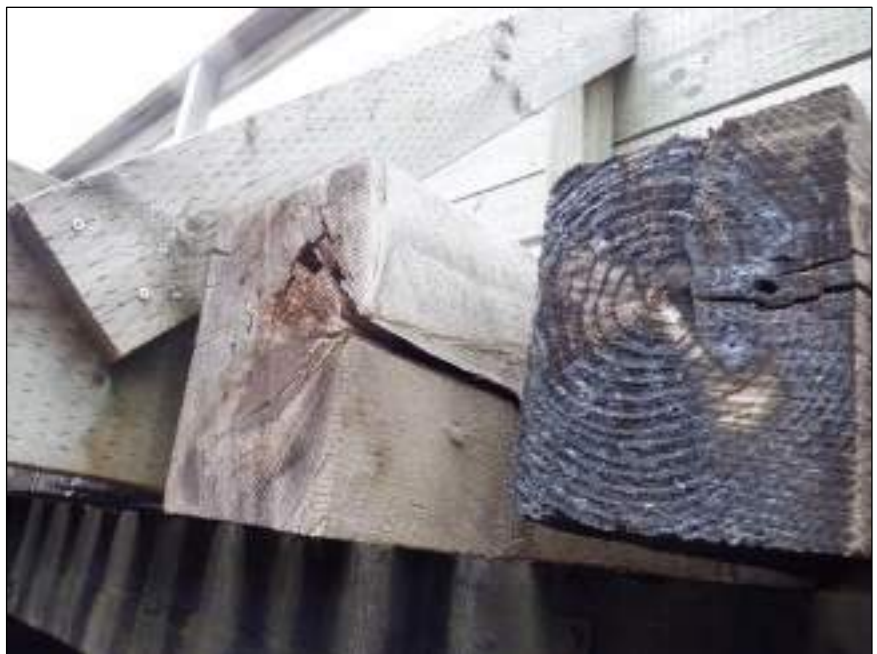
Photo 18:

East approach North side near bent 4.
Newer style rail tie is decaying.

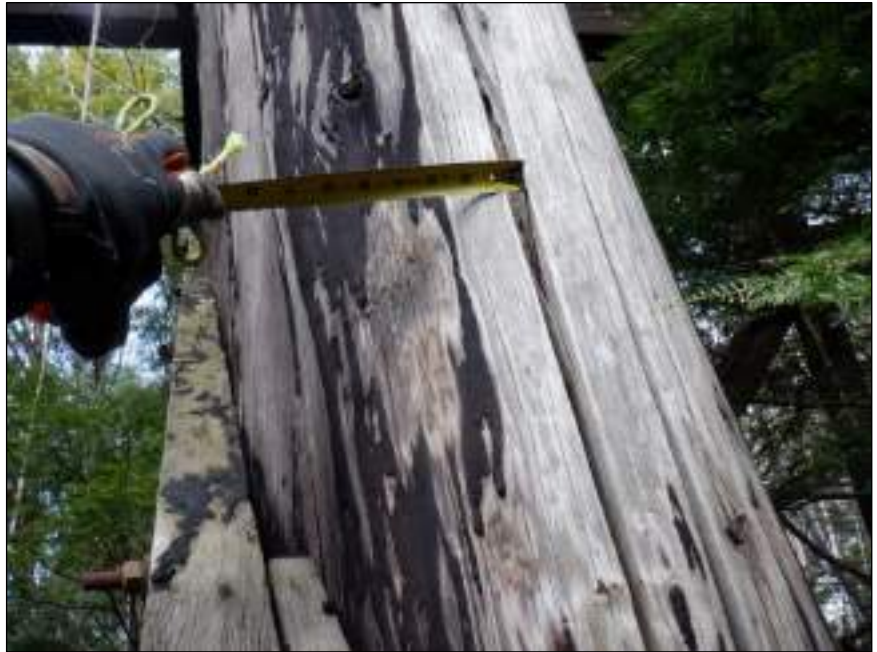
Photo 19:

East approach South side. General cracking.

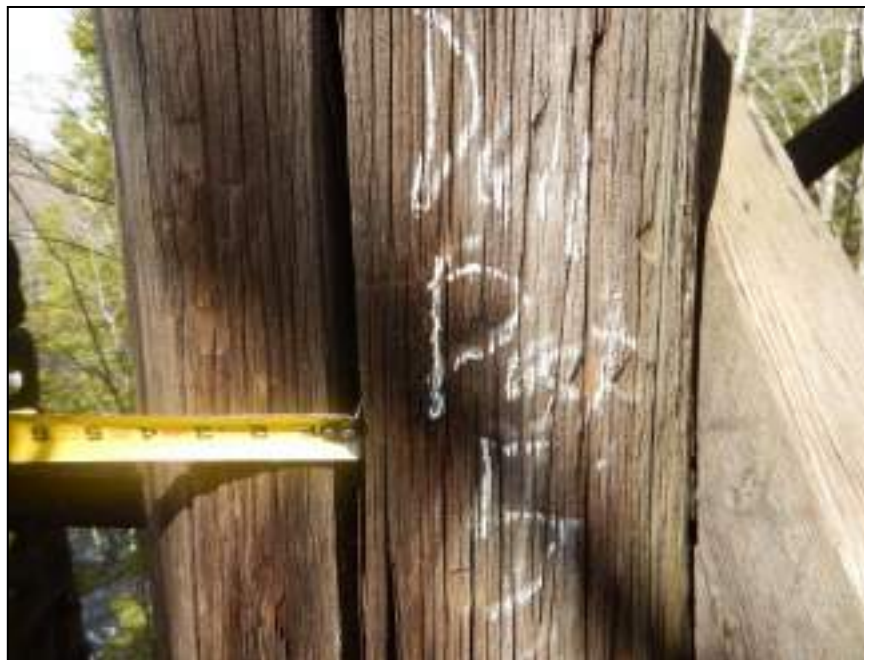
Photo 20:

East approach South side. General cracking.

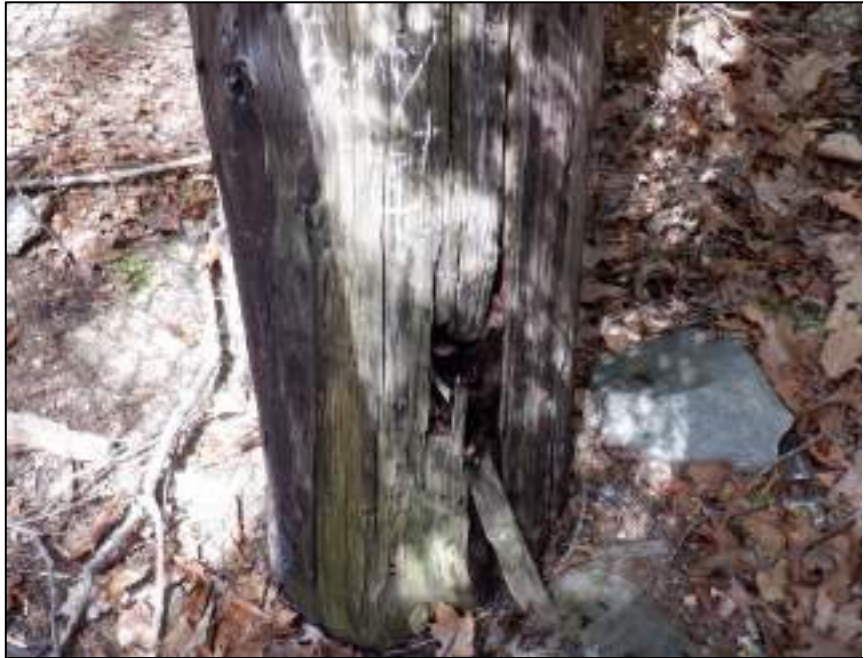
Photo 21:

East approach bent 7 post 1. Decay at footing.

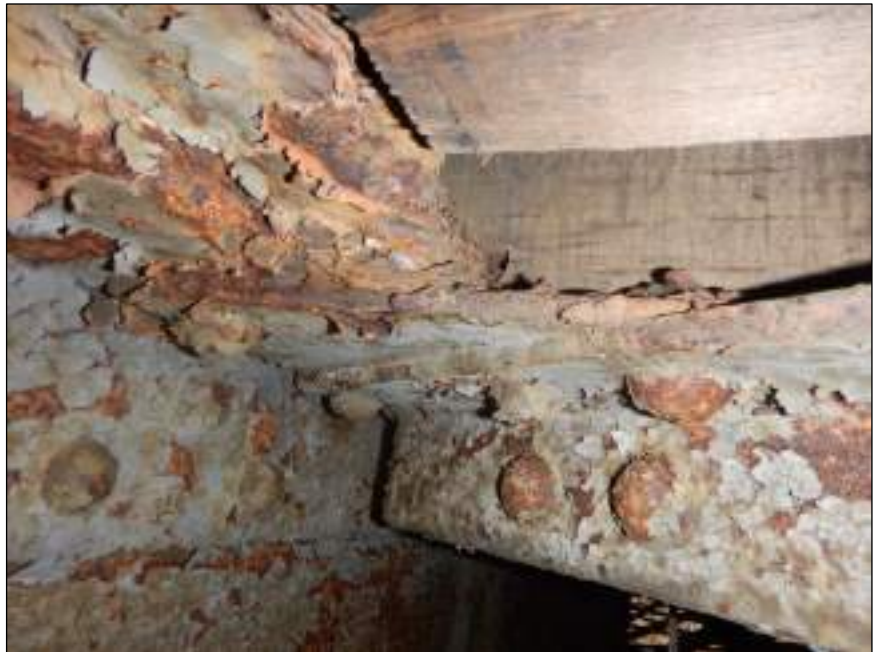
Photo 32:

- Some heavier amounts of corrosion were found along the top flanges of the girders where dirt and debris can collect and retain moisture, which has resulted in pack rust and deterioration of the angle bracing and gusset plates in these areas.

Girder East span. Pack rust and deterioration at a top lateral bracing-girder gusset plate.

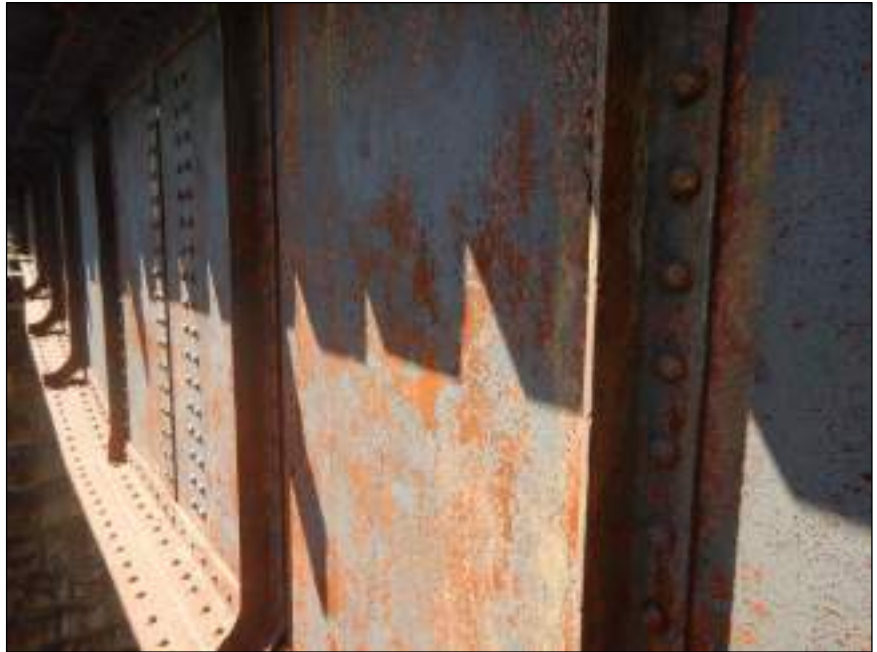
Photo 33:

Girder East span South side. Coating failure throughout.

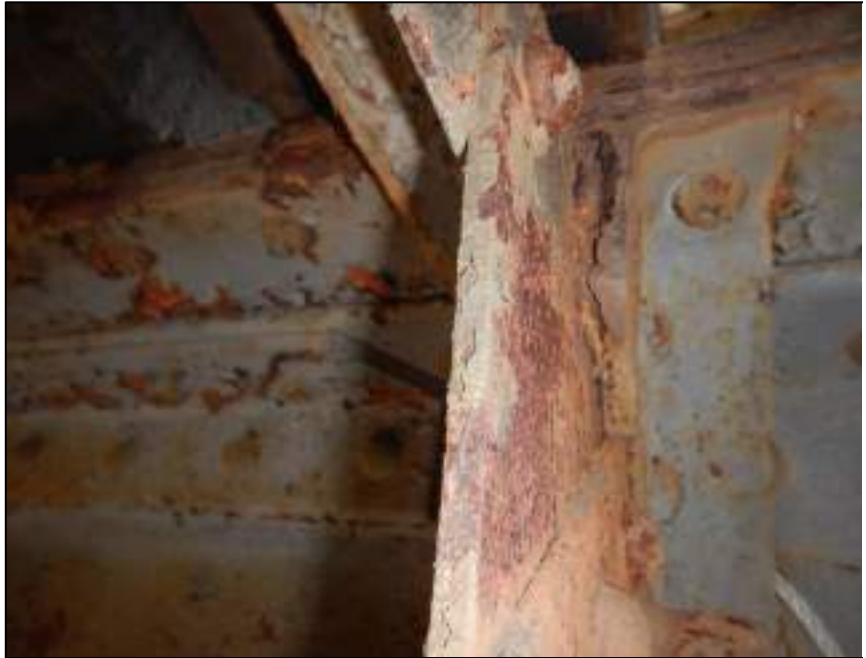
Photo 35:

Girder West span. Pack rust and deterioration at a top lateral bracing-girder gusset plate.

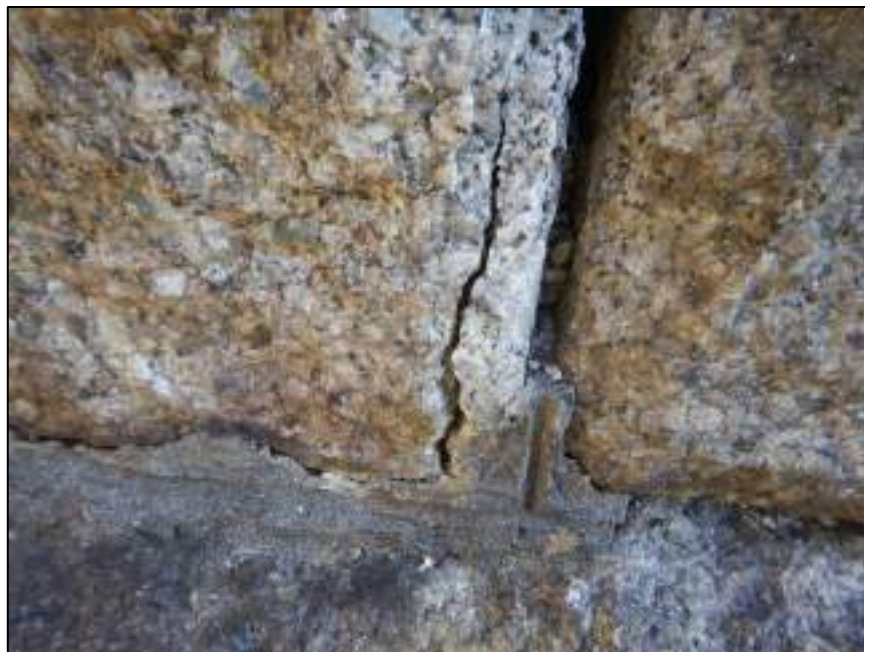
Photo 44:

East pier. Cracked granite stone.

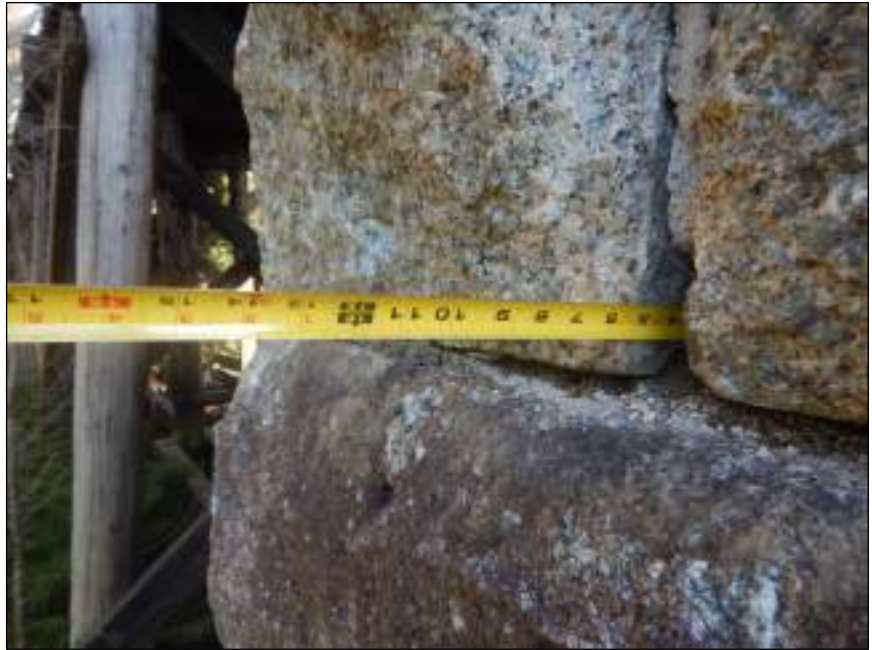
Photo 45:

East Pier. Missing mortar 6" depth.

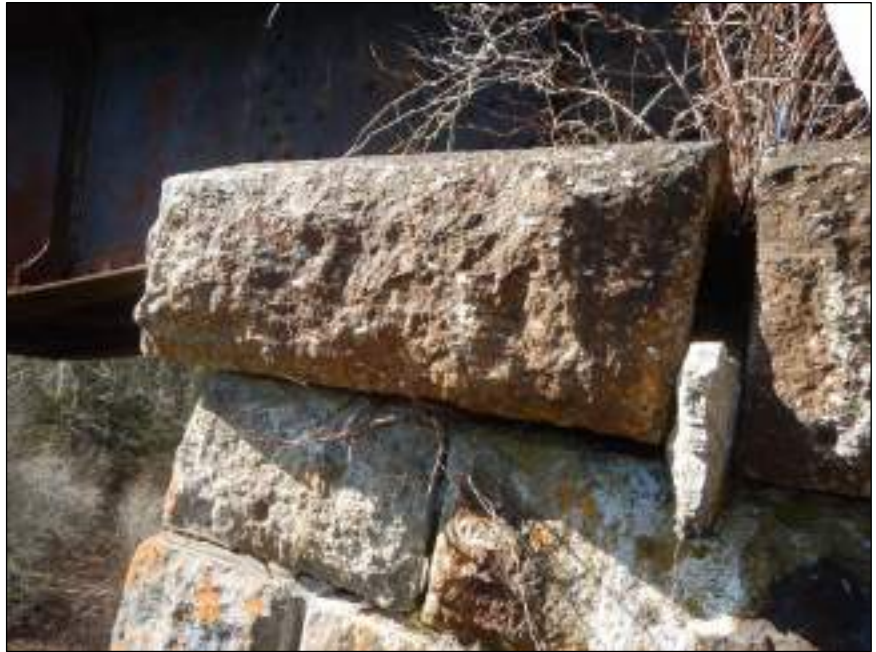
Photo 47:

Note that the center pier cap and nearby stones show evidence movement. This could be the result of failed girder sliding bearings.

Center pier South side. Cap has shifted.

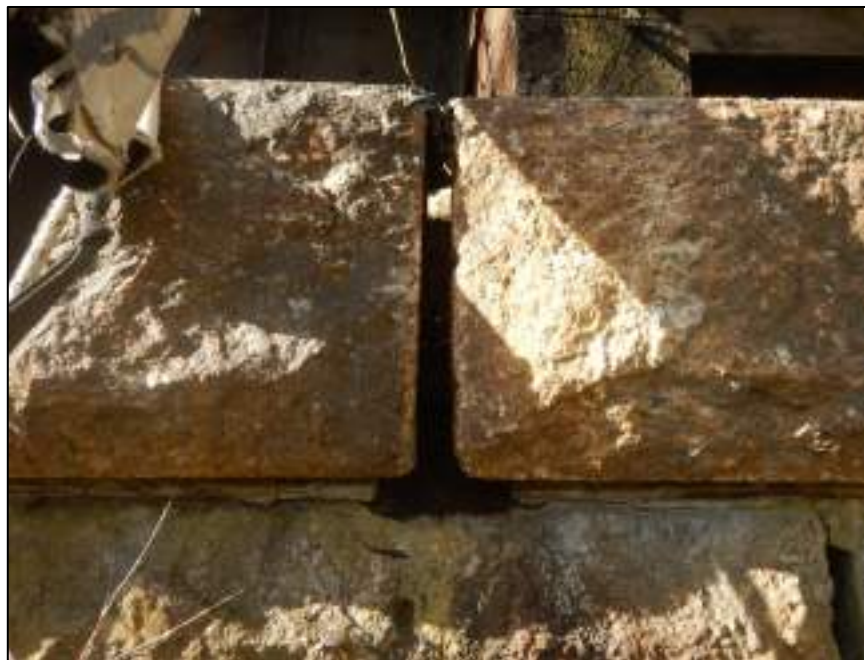
Photo 48:

Center pier. Missing mortar throughout the pier cap.

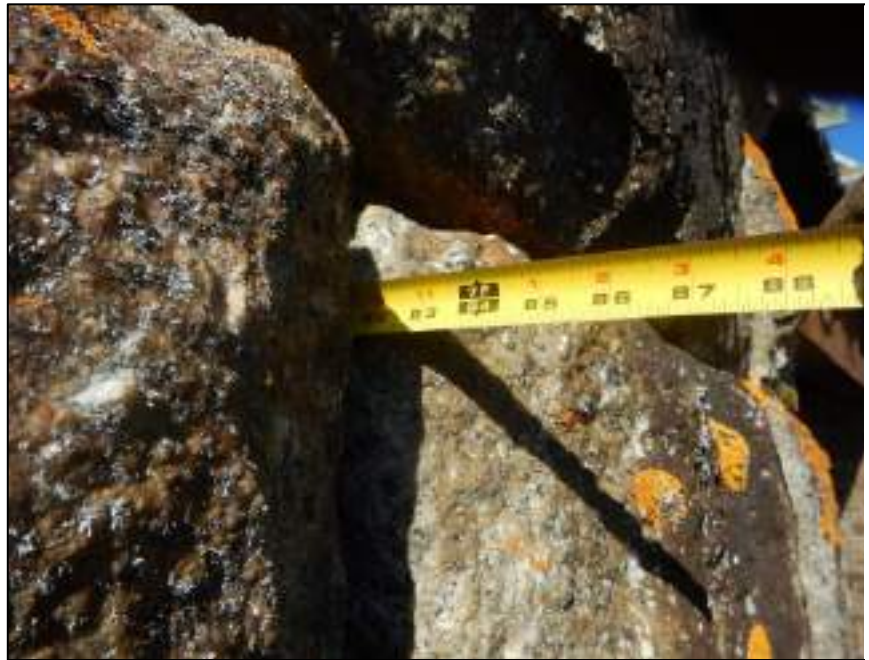
Photo 49:

Center pier. Missing mortar. Tape measure inserted approx. 7".

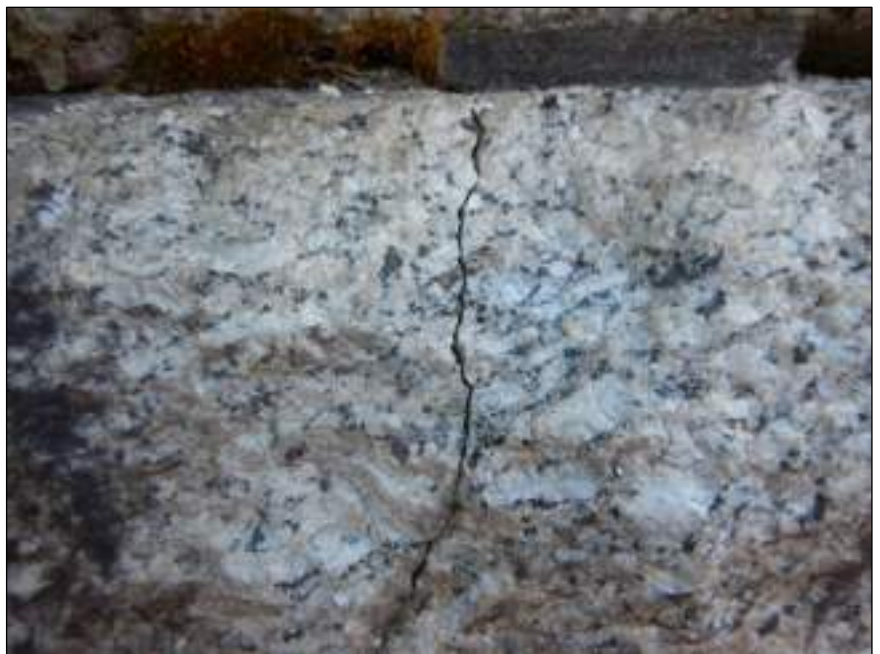
Photo 50:

Center pier. Cracked granite stone.

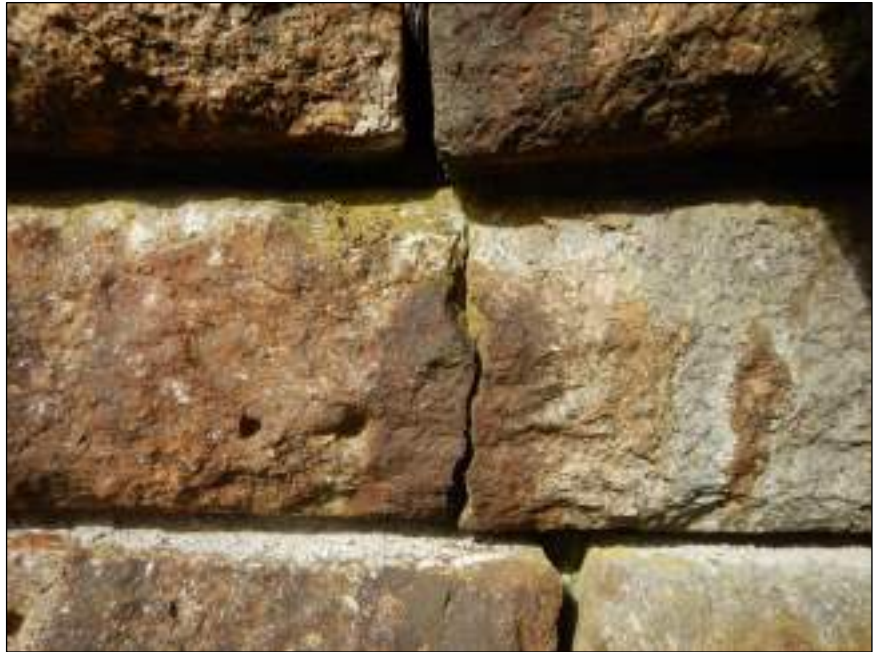
Photo 51:

Center pier. Cracked granite stone.

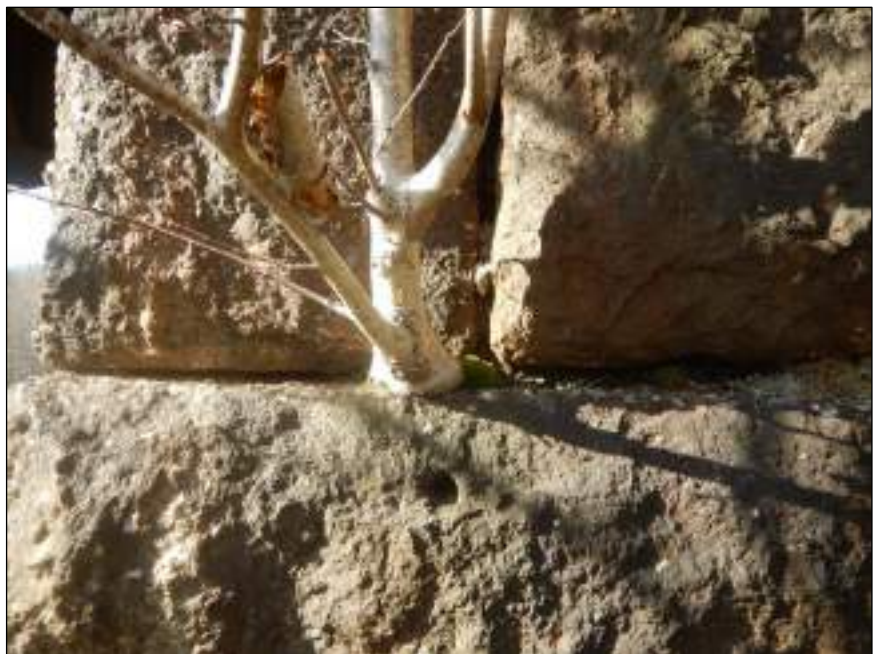
Photo 52:

Center pier. Vegetation growth throughout.

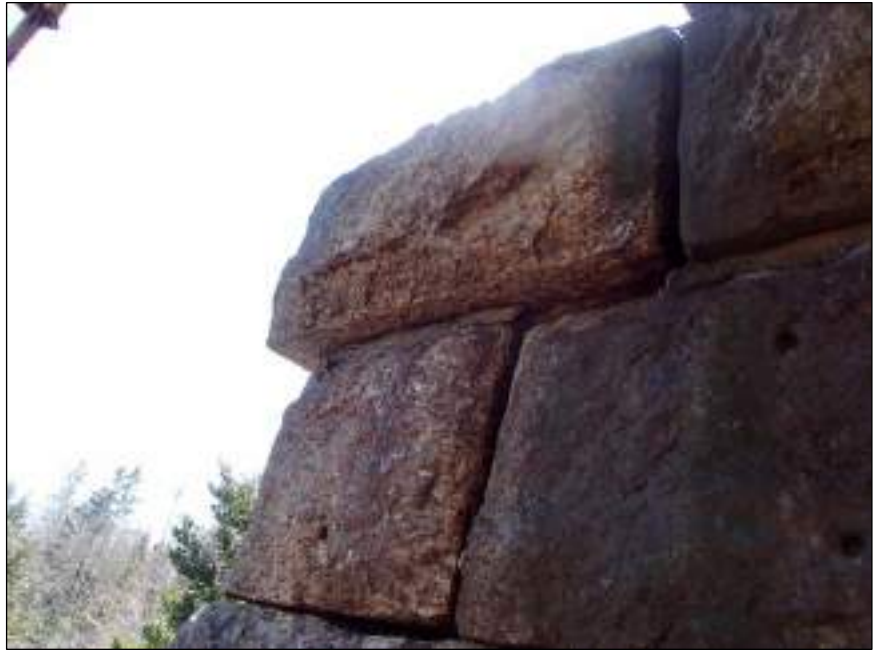
Photo 53:

West pier. Missing mortar at the pier cap.

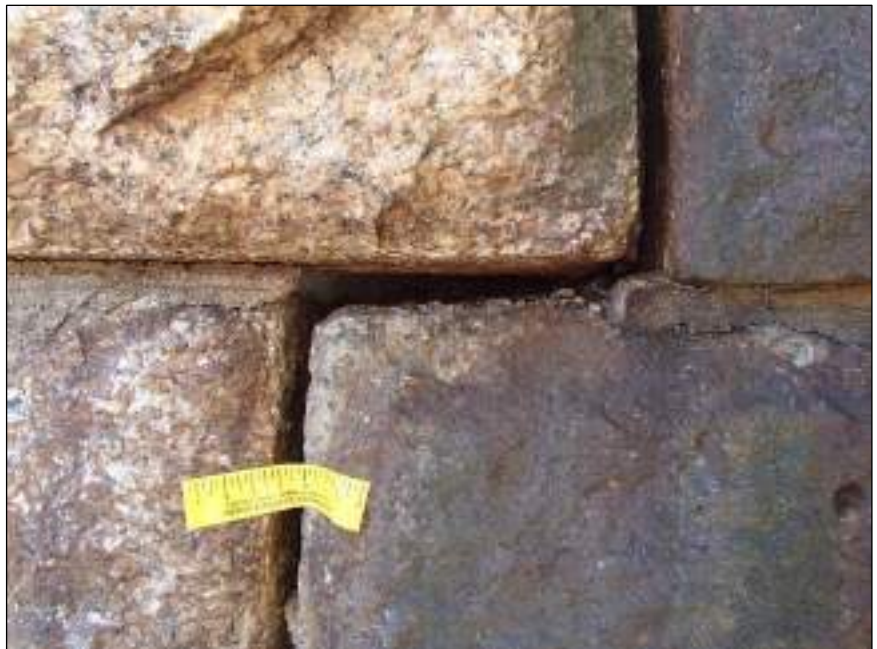
Photo 54:

West pier. Missing mortar.

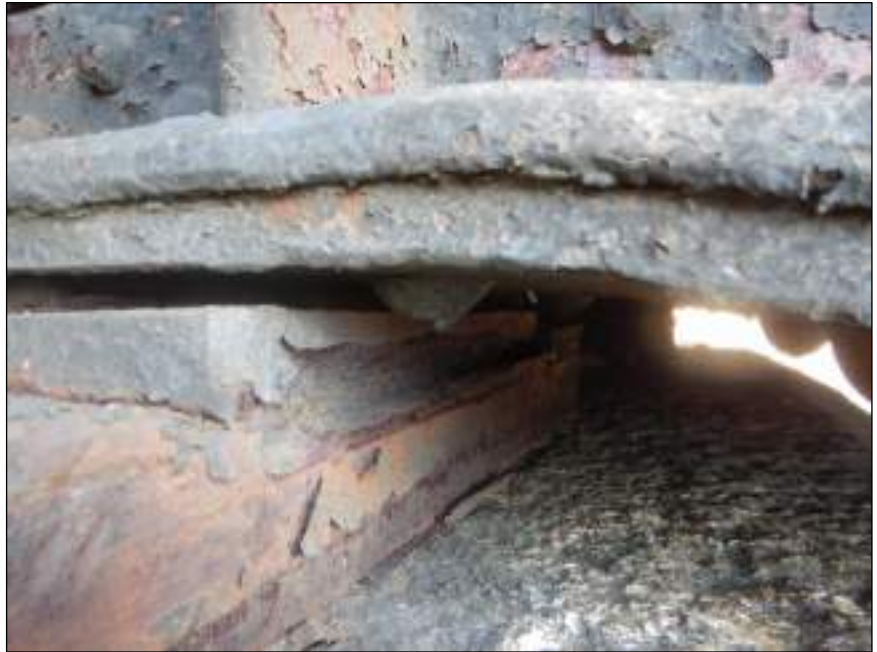
Photo 55:

It has been observed and reported by our sub-consultant high angle inspection crew that the girder bearing assemblies exhibit significant visible corrosion throughout and that the sliding bearings are no longer functioning. The sliding bearings are therefore considered to have failed. As a result of this failure, the tops of the stone masonry piers are exposed to and forced

East pier bearing. Heavy corrosion throughout.

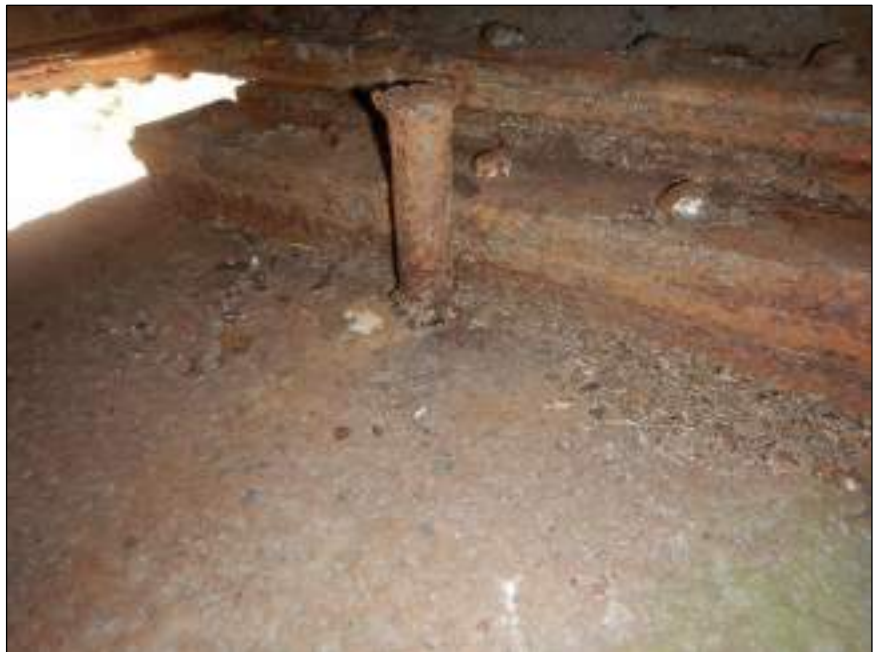
Photo 56:

Center pier bearing. Heavy corrosion and no sign of expansion.

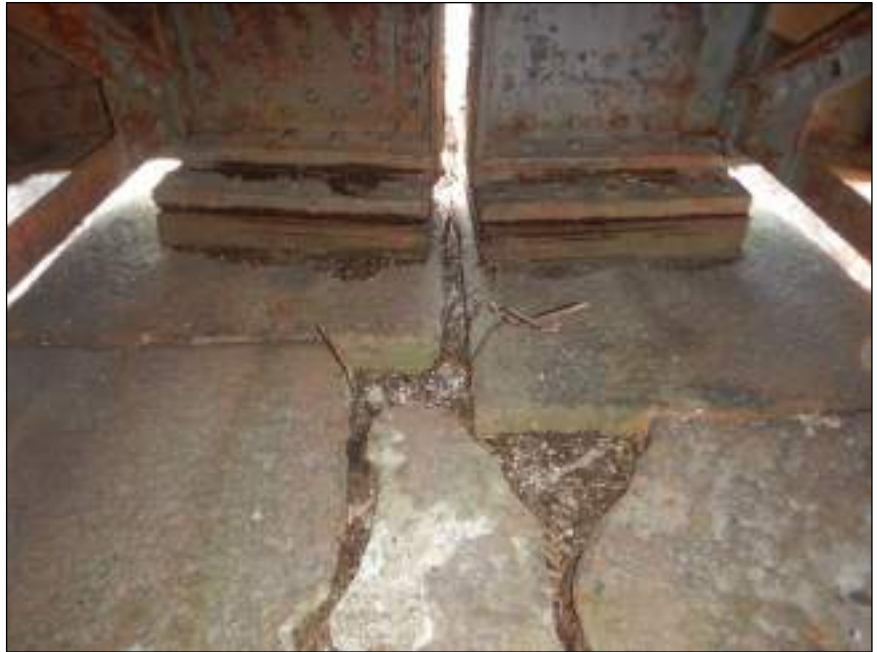
Photo 57:

Center pier bearing. Heavy corrosion and no sign of expansion.

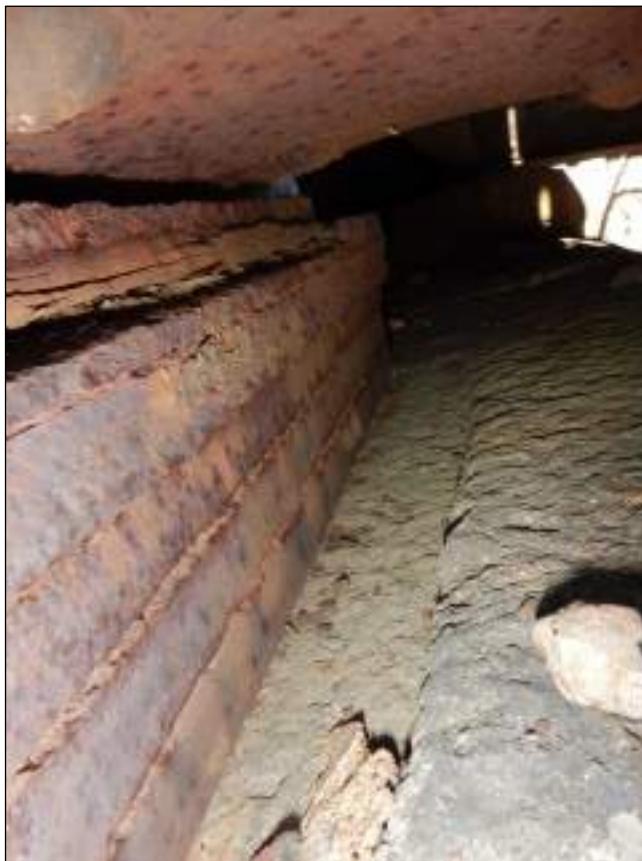
Photo 58:

West pier bearing. Heavy corrosion throughout.

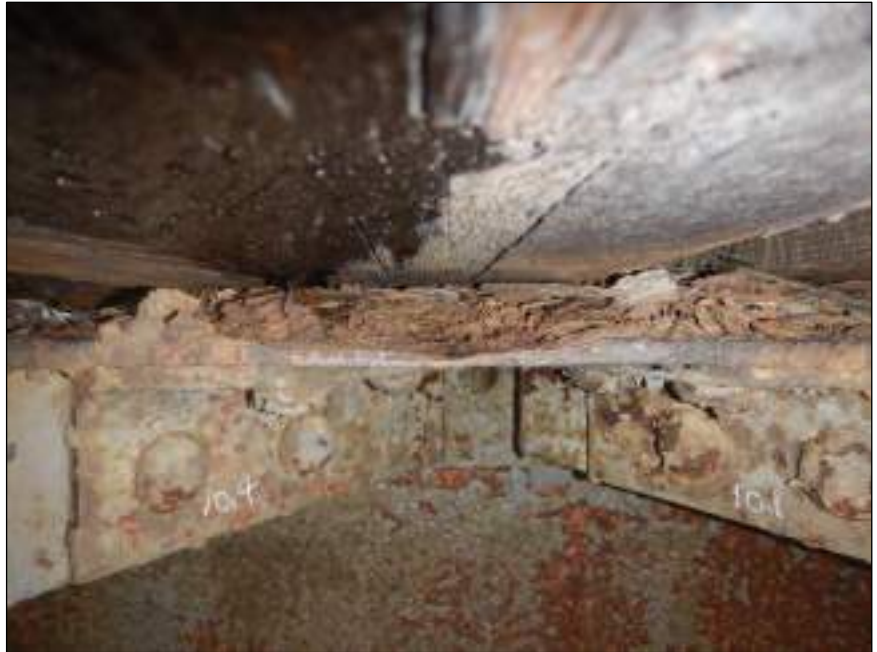
Photo 1:

Top chord lateral diagonal bracing connection plates. Pack rust on topside between plate and tie.
