GOLD RIVER MULTI- USE BRIDGE

GOLD RIVER, NOVA SCOTIA

CONDITION ASSESSMENT REPORT

September 26, 2021 (REVISION No. 1)

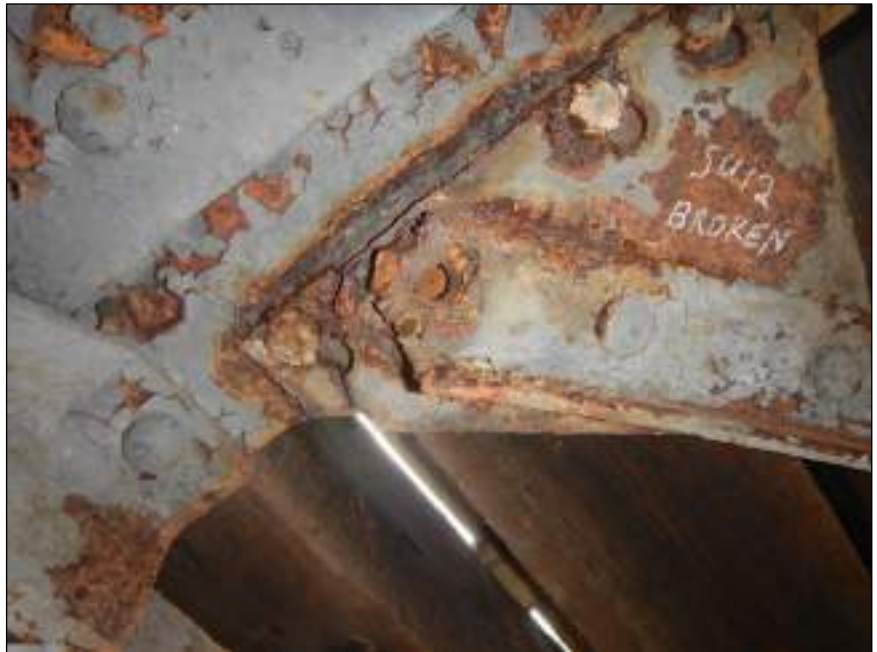
Photo 2:

Top chord lateral diagonal bracing connection plates. Heavy corrosion and missing rivets.

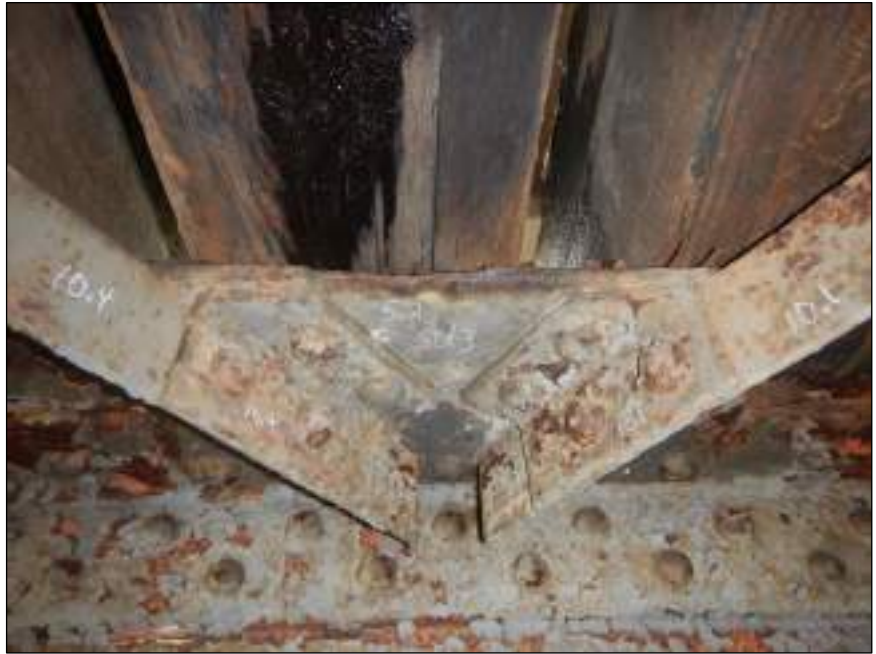
Photo 3:

Top chord lateral diagonal bracing connection plates. Pack rust on topside between plate and tie.

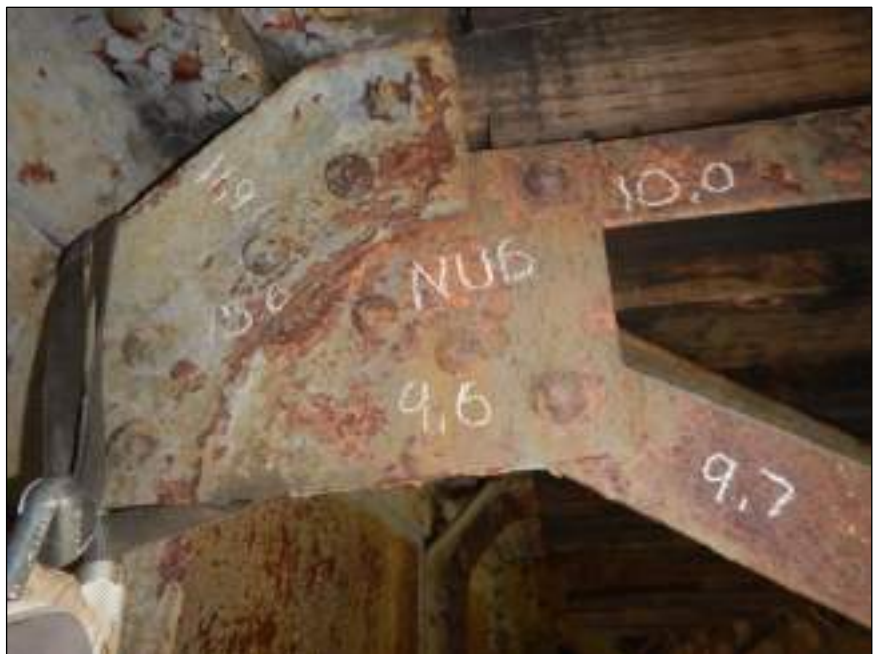
Photo 4:

Vertical cross bracing upper corner connection plates. Heavy amount of pack rust between members.

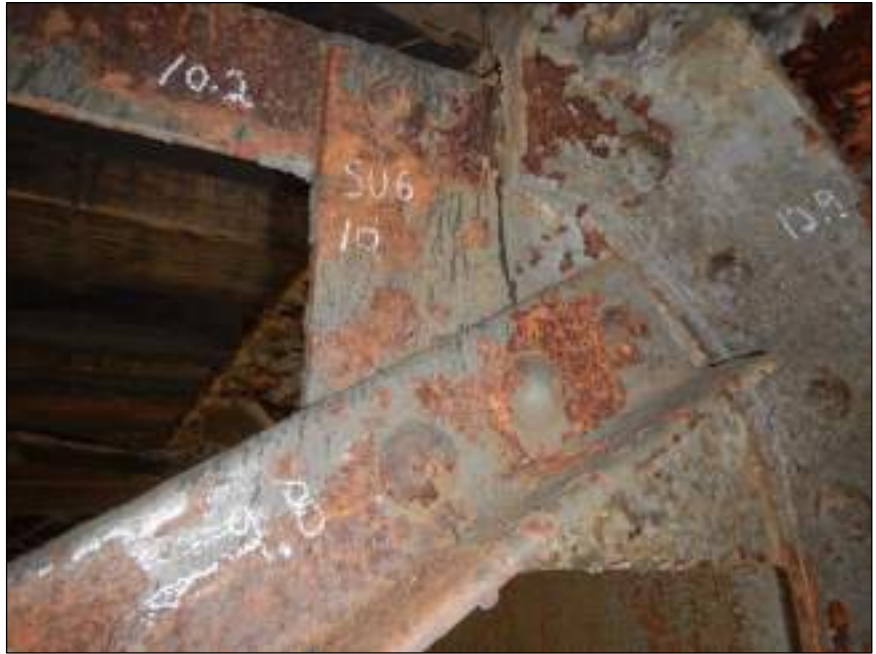
Photo 5:

Vertical cross bracing upper corner connection plates. Heavy amount of pack rust between members.

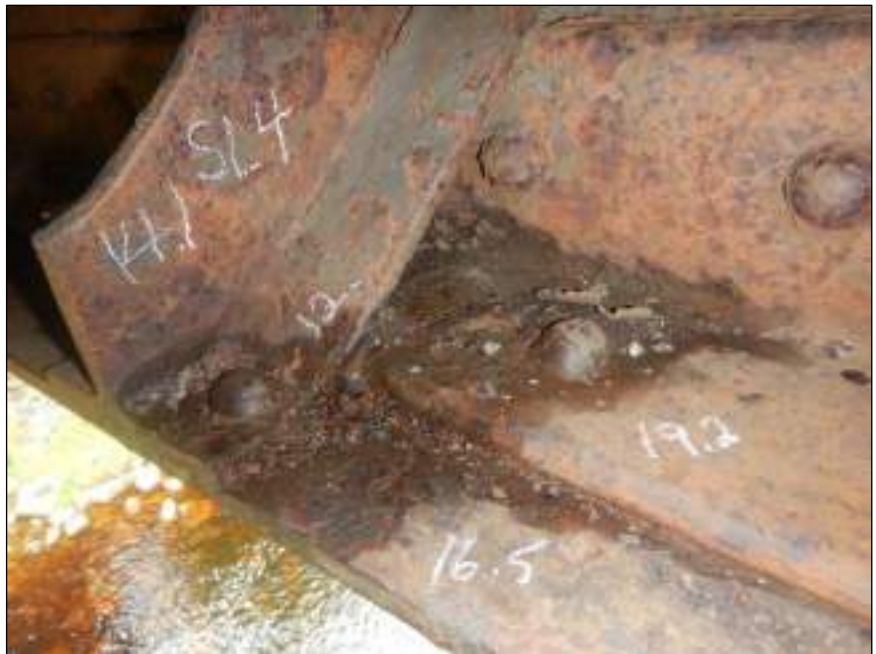
Photo 6:

Bottom flange stiffener connection where the stiffener ties into the flange. Heavy amount of pack rust between members.

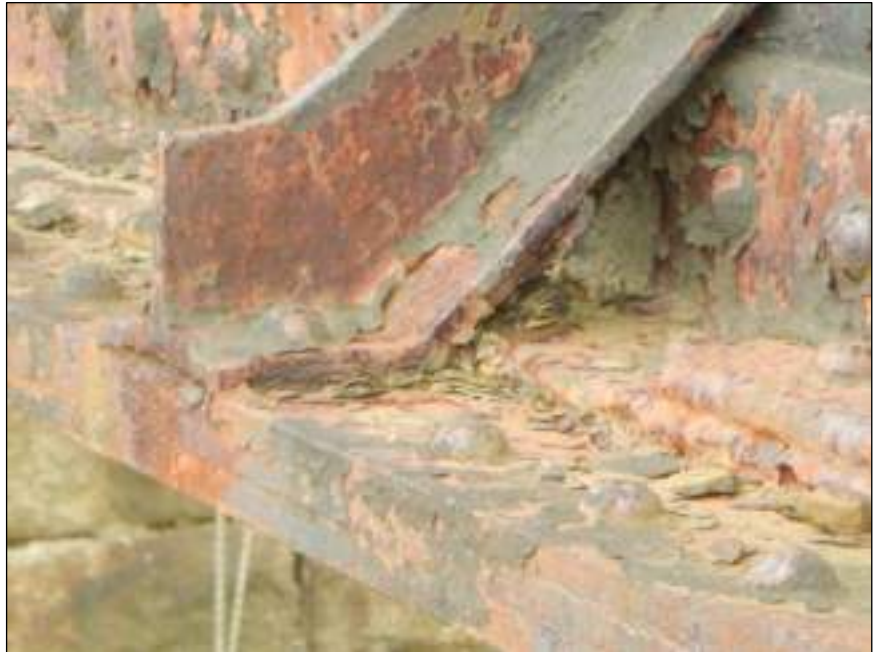
Photo 7:

Bottom flange stiffener connection where the stiffener ties into the flange. Heavy amount of pack rust between members.

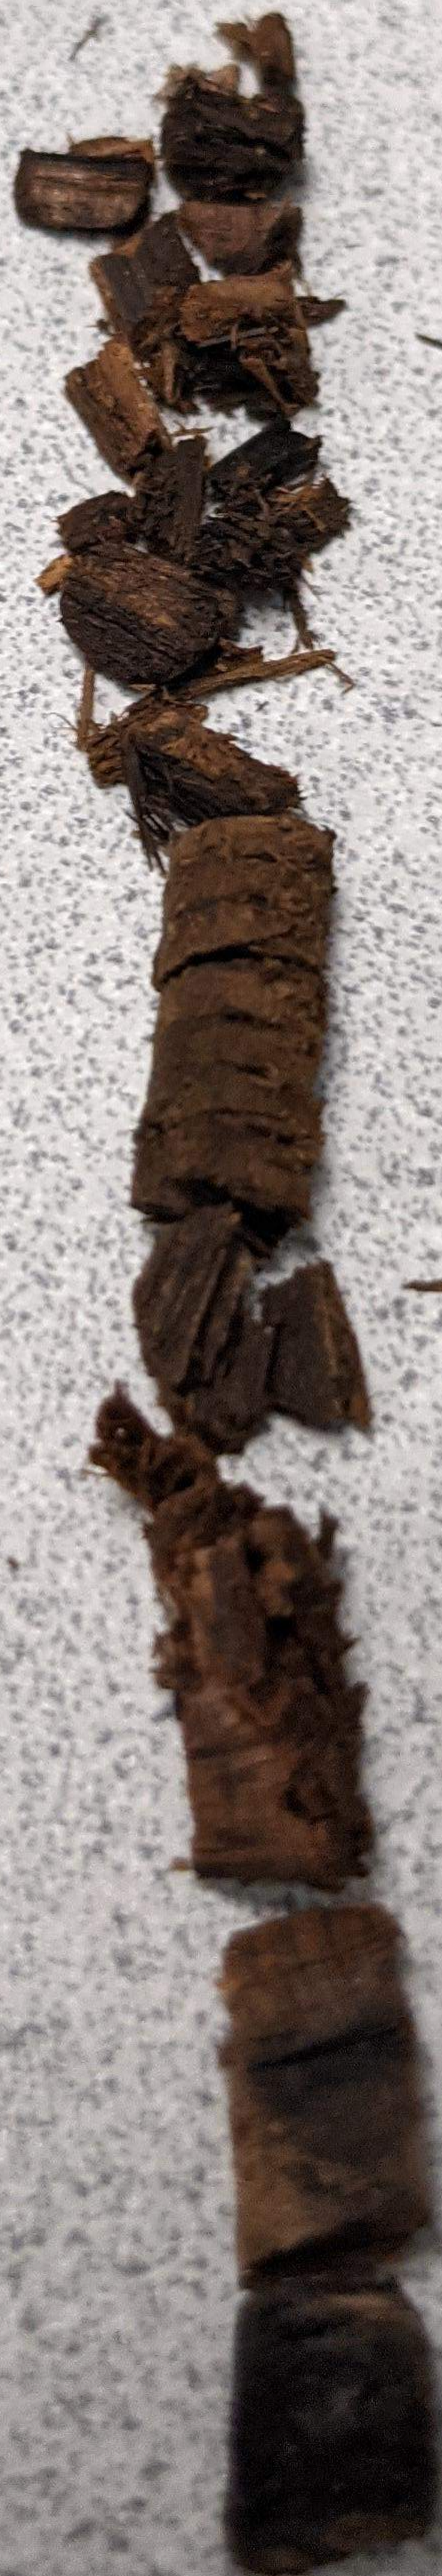
PHOTO 60:
CORE EXAMPLE OF ROTTEN POST

- g) Most timber core samples at creosoted ties, stringers and pile caps exhibited fair to good internal cross section integrity, even if some of the cores were broken during the extraction process. However, several cores taken from trestle piles and braces exhibited delamination and evidence of internal rot. See Photos 59-65

East Side
South Face
Bent 7 post-6
Core Sample
PIC

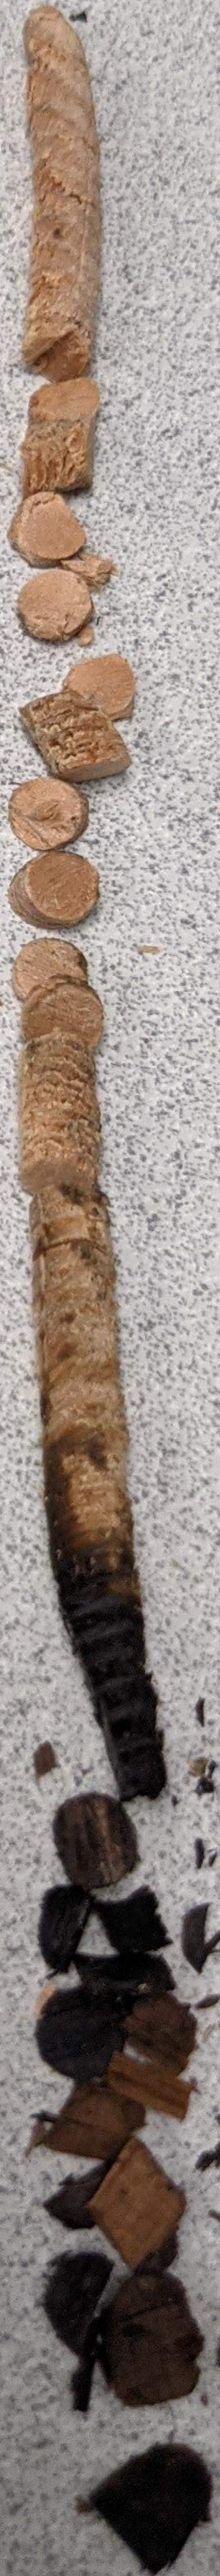
PHOTO 62:
CORE EXAMPLE OF ROTTEN POST

East Side
North Face
Bent 3 post 3
Core Sample
pic
