Bacteria Monitoring Results from Goose Creek and Rafuse Cove, Western Shore, NS

COASTAL ACTION

February 23, 2022

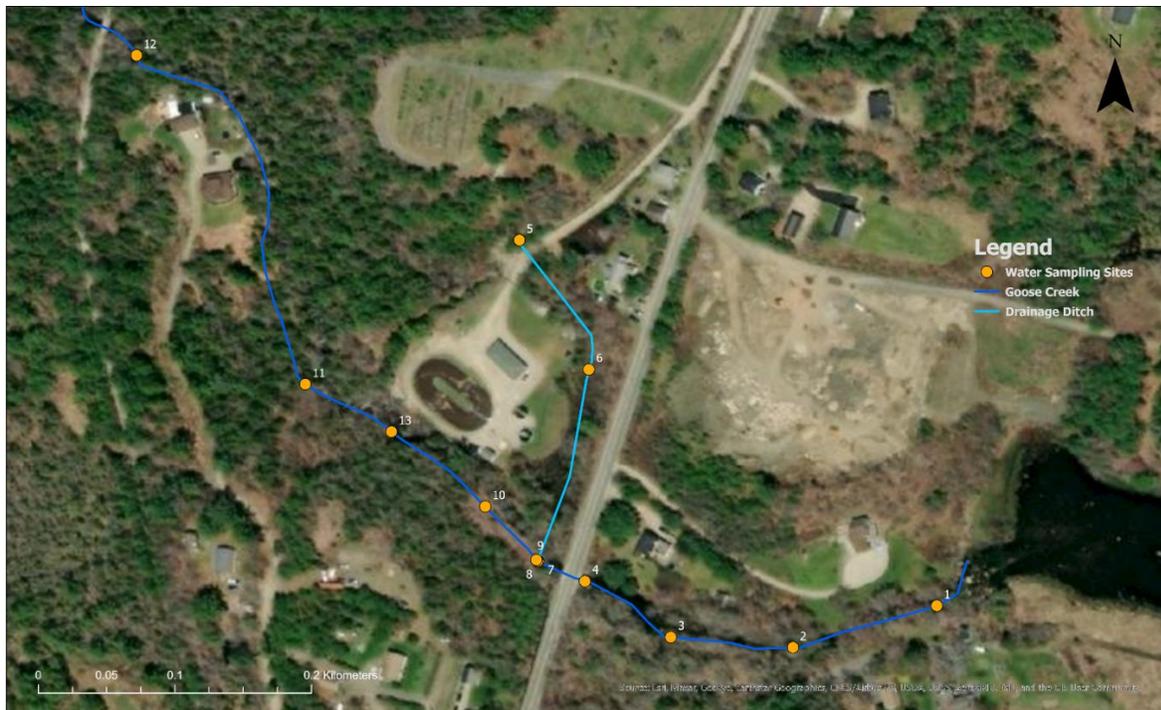
Figure 1. Bacteria sample sites on Goose Creek and a drainage channel near the Western Shore Sewage Treatment Plant.

Surface water samples were collected from multiple locations in Goose Creek, beginning at the mouth of the stream and travelling upstream as far as the Chester Connection Trail. Sample sites were placed between (i.e., upstream and downstream) residential properties and other potential contamination sources. Additional samples were collected when possible (i.e., when water was present/flowing) from a drainage ditch that runs parallel to Boehner Road and then flows through a forested wetland habitat along the northern and eastern sides of the Westermm Shore Sewage Treatment Plant fenceline before discharging into Goose Creek just upstream of Hwy 3 (Figure 1).

Site Number	Description of bacteria sample sites
1	The mouth of Goose Creek before draining into the ocean
2	Upstream/downstream of residential properties
3	Upstream/downstream of residential properties
4	Downstream of Hwy 3 bridge
5	Drainage channel upstream of livestock property
6	Drainage channel downstream of livestock property (culvert outflow)
7	1 m downstream of the drainage channel
8	The mouth of the drainage channel before entering Goose Creek
9	1 m upstream of the drainage channel
10	The mouth of the Western Shore Sewage Treatment Plant effluent pipe
11	Upstream of Western Shore Sewage Treatment Plant
12	Upstream of residential property / downstream of Chester Connection Trail bridge
13	Mid-way along the Western Shore Sewage Treatment Plant property

Sample sites were strategically placed in order to isolate the runoff from this property. Site 5 is located in the drainage ditch upstream of the livestock impacts. Site 6 is located immediately downstream of these impacts, and sites 7, 8, and 9 are placed along the drainage and leaching zone of this drainage channel where it joins Goose Creek.

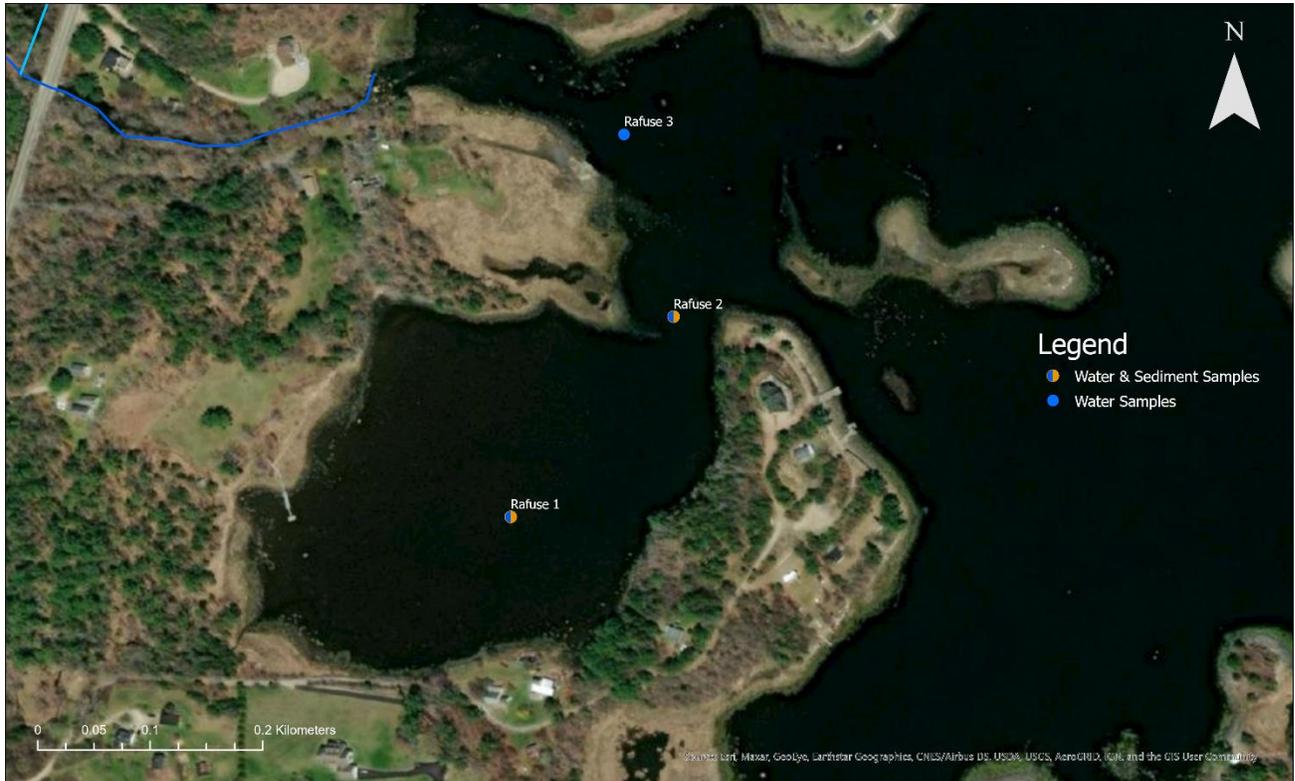
Figure 2. Water and sediment sample sites in Rafuse Cove, near the mouth of Goose Creek in Western Shore, NS.

Surface water samples were collected from three locations in Rafuse Cove on September 28, 2021 (Figure 2) and analyzed for enterococci bacteria, the recommended fecal indicator species in marine environments (Health Canada 2012). This sampling event occurred during drought conditions (i.e., > 48 hours without precipitation).

Benthic sediment samples were collected from two locations in Rafuse Cove on September 28, 2021, and analyzed for E. coli bacteria (Figure 2). This sampling event occurred during drought conditions. Sediment samples were collected using a gravity corer. A gravity core of the top 10-20 cm of benthic sediment was collected and transferred to laboratory-provided, sterilized jars.

Water samples collected from Rafuse Cove during drought conditions displayed low concentrations of enterococci bacteria at sites located in Rafuse Cove; however, one exceedance of Health Canada's primary contact enterococci guideline was observed near the marine discharge area of Goose Creek (Rafuse 3).
