GOLD RIVER MULTI- USE BRIDGE

GOLD RIVER, NOVA SCOTIA

CONDITION ASSESSMENT REPORT

September 26, 2021 (REVISION No. 1)

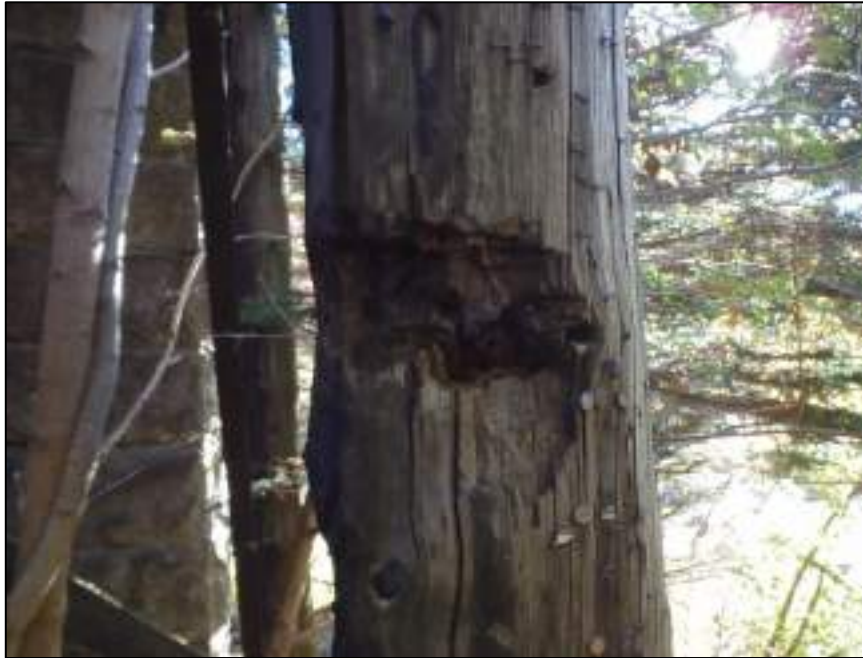
Photo 12:

West approach bent 11 post 6.
Vandalism.

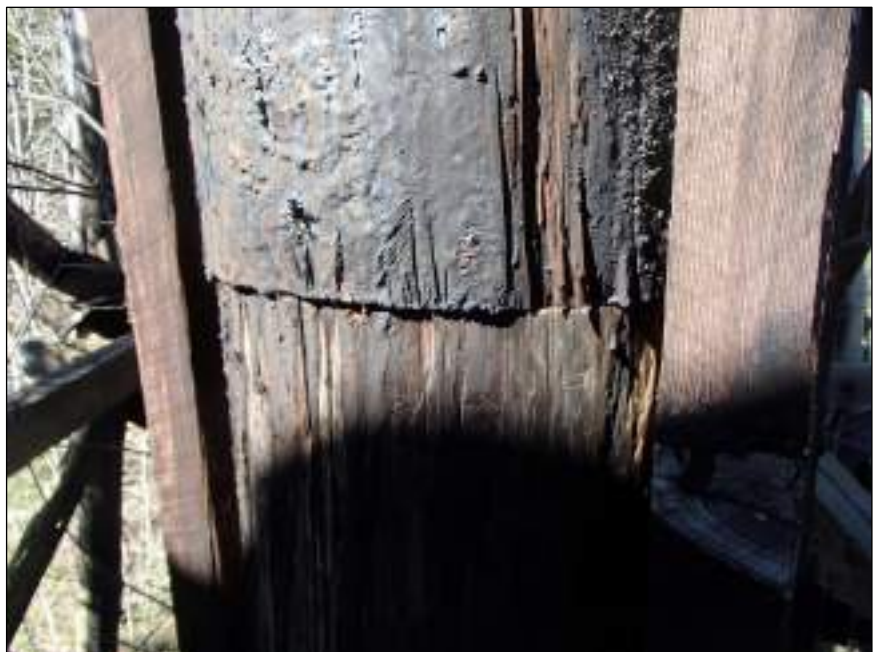
Photo 23:

Spliced post. East approach bent 6
post 3.

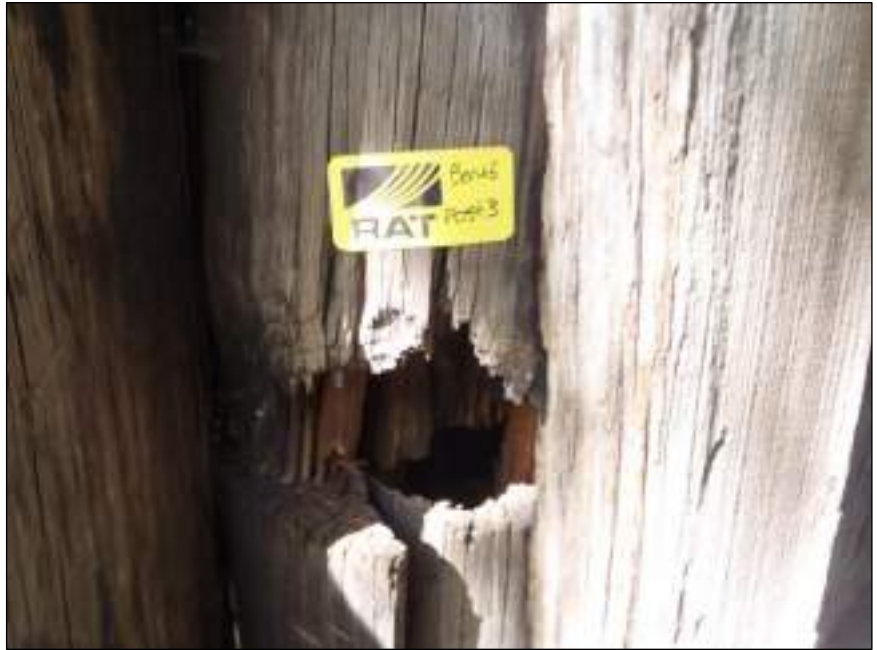
Photo 24:

Bottom flange West girder.

2.13"

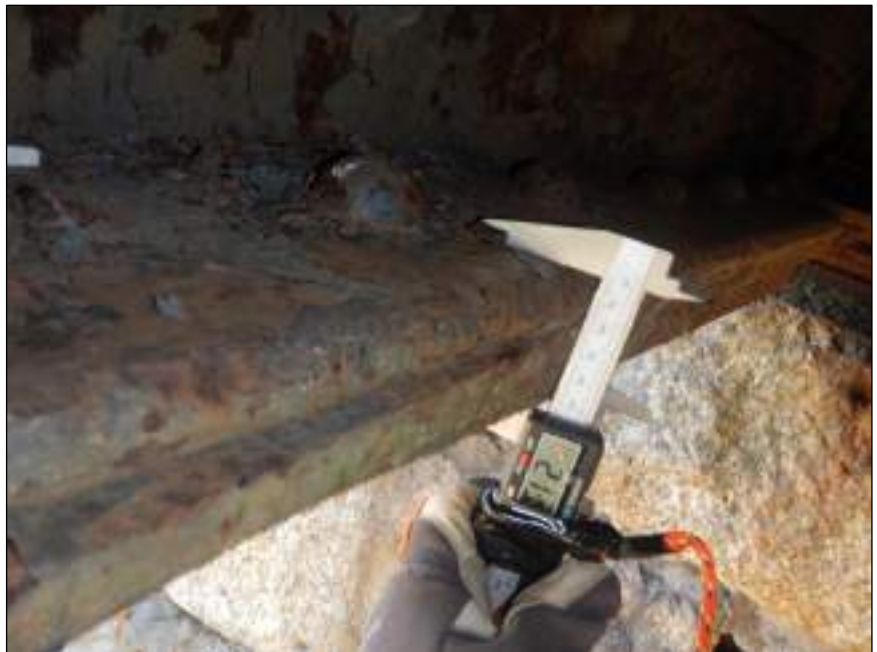
Photo 25:

Top flange West girder.

2.32"

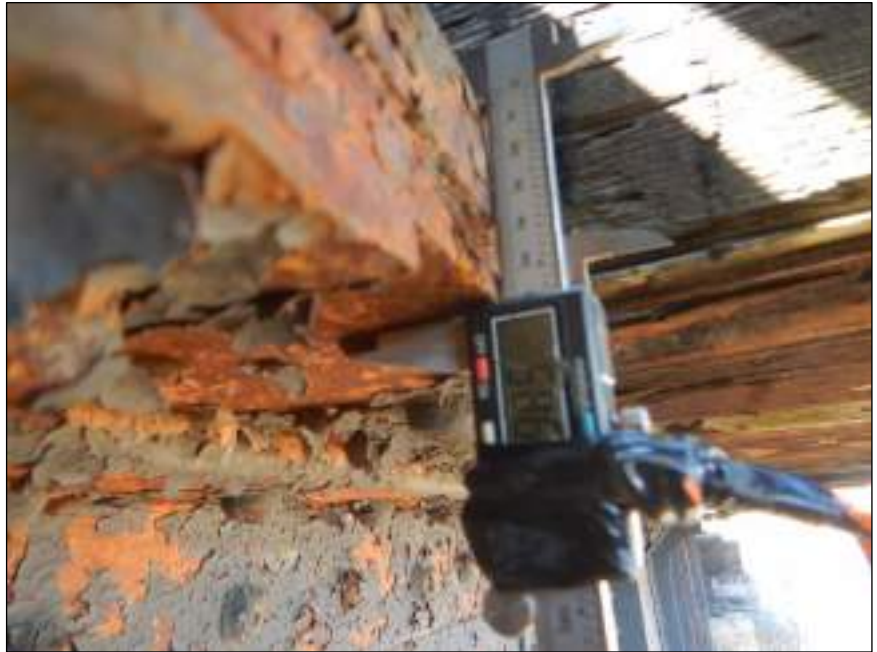
Photo 26:

Bottom flange West girder.

1.38"

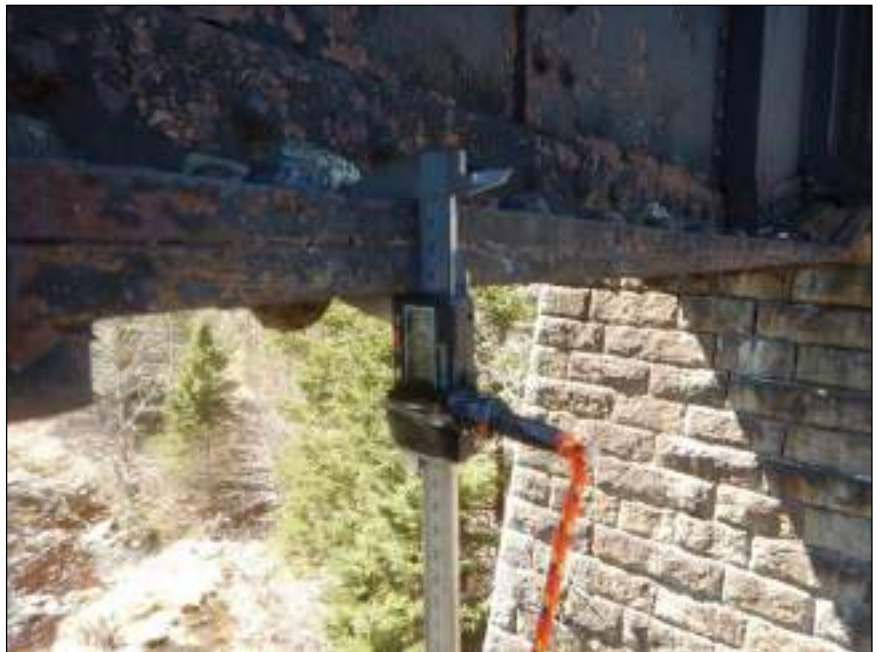
Photo 27:

Bottom flange West girder.

2.21"

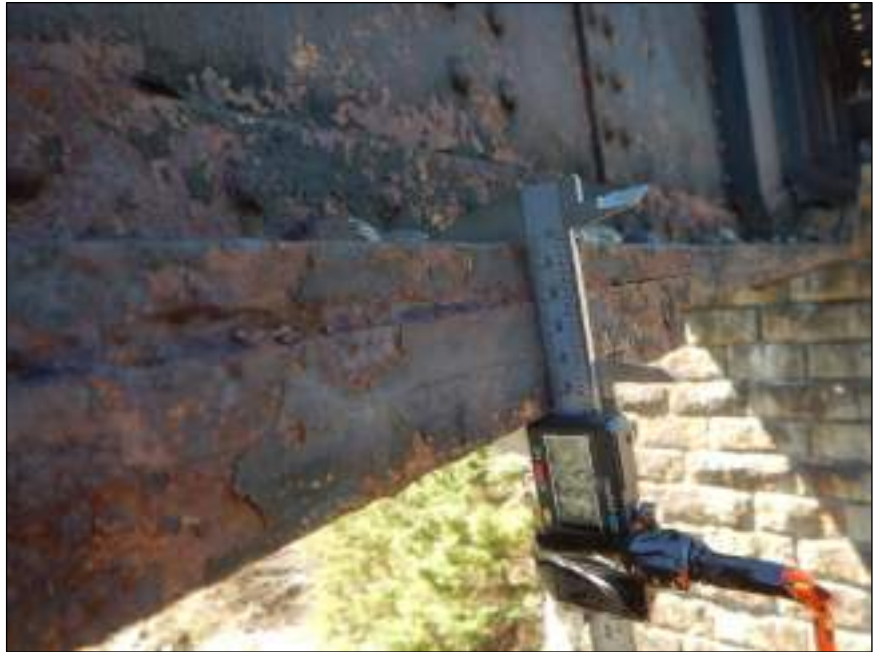
Photo 28:

2.14"

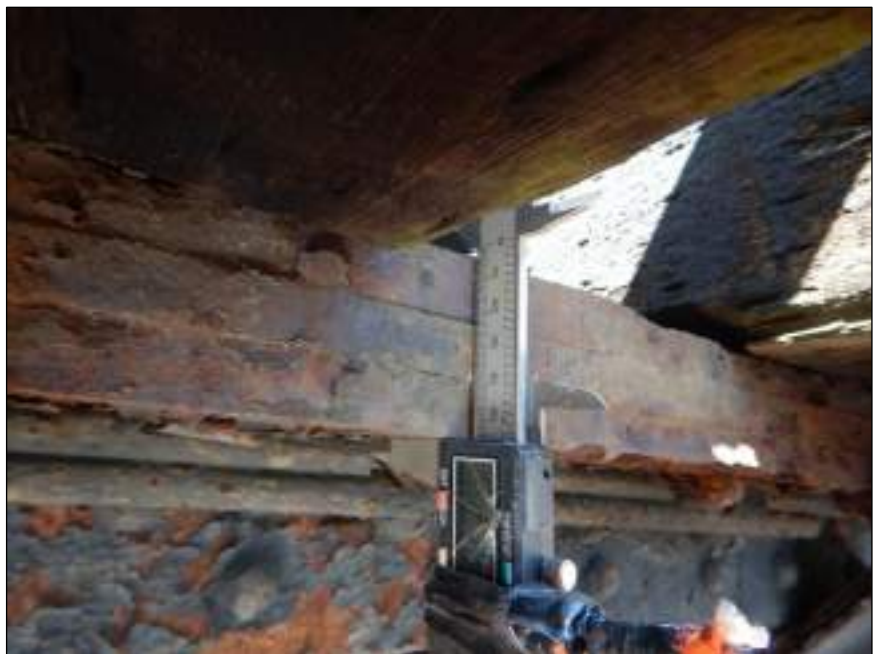
Photo 29:

Bottom flange West girder.

2.17"

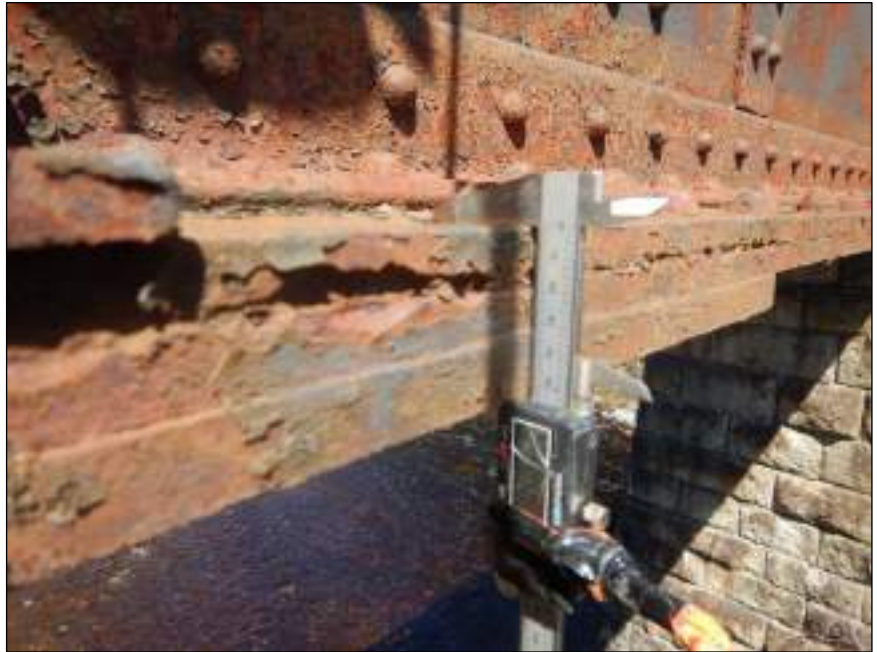
Photo 30:

Top flange East girder.

2.01

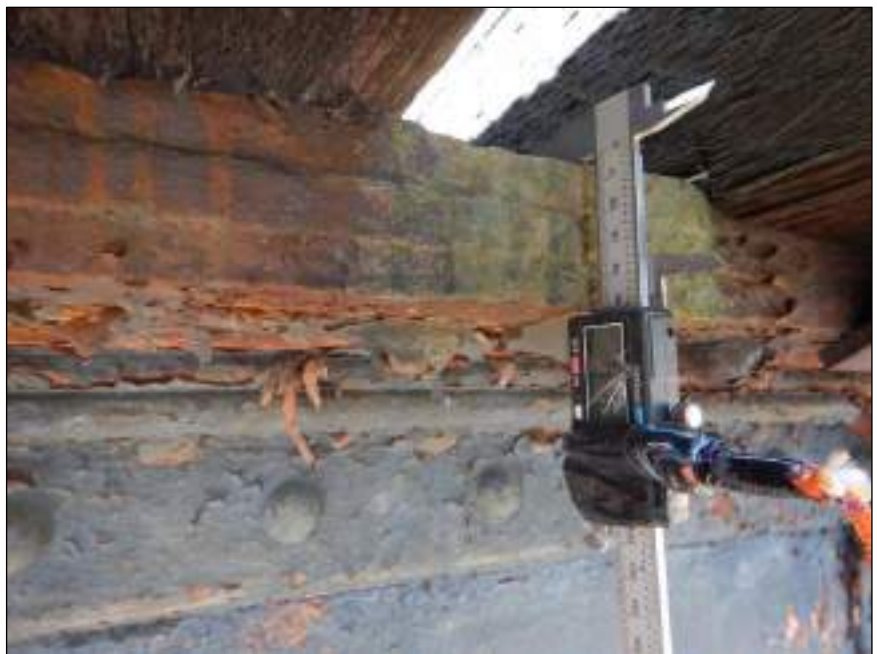
Photo 31:

Bottom flange East girder.

2.14"

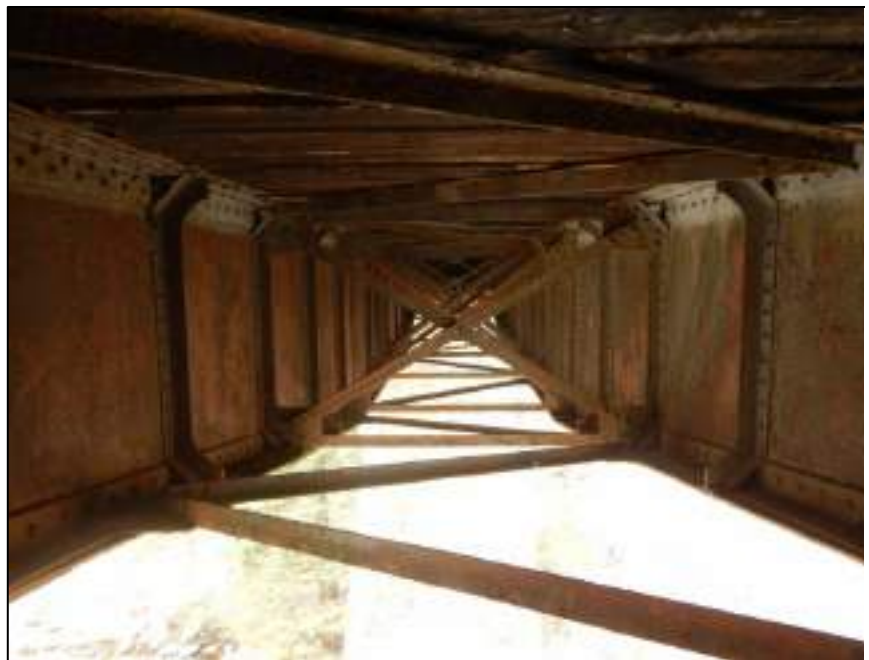
Photo 35:

Girder West span. Pack rust and deterioration at a top lateral bracing-girder gusset plate.

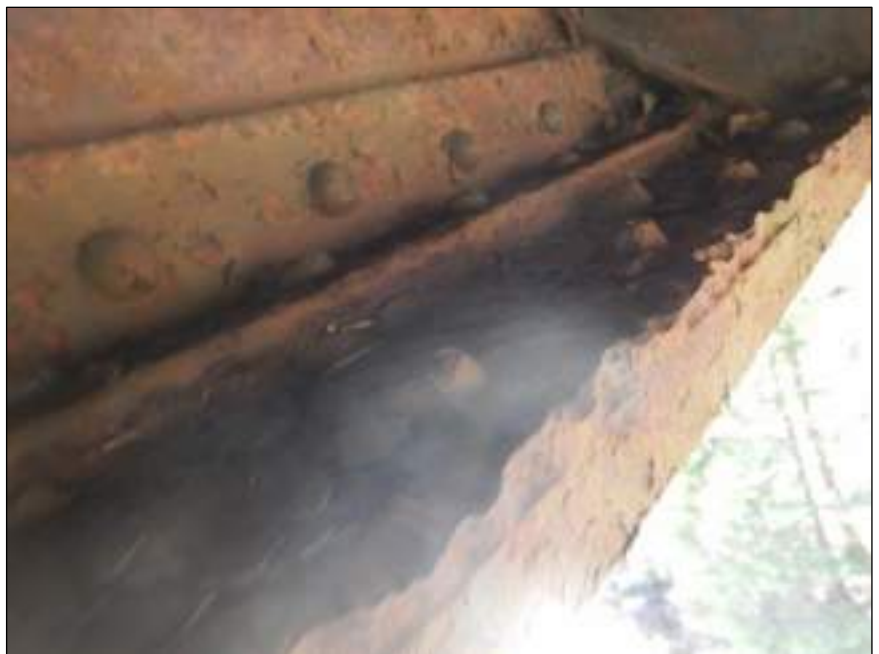
Photo 37:

General upper corner connection.

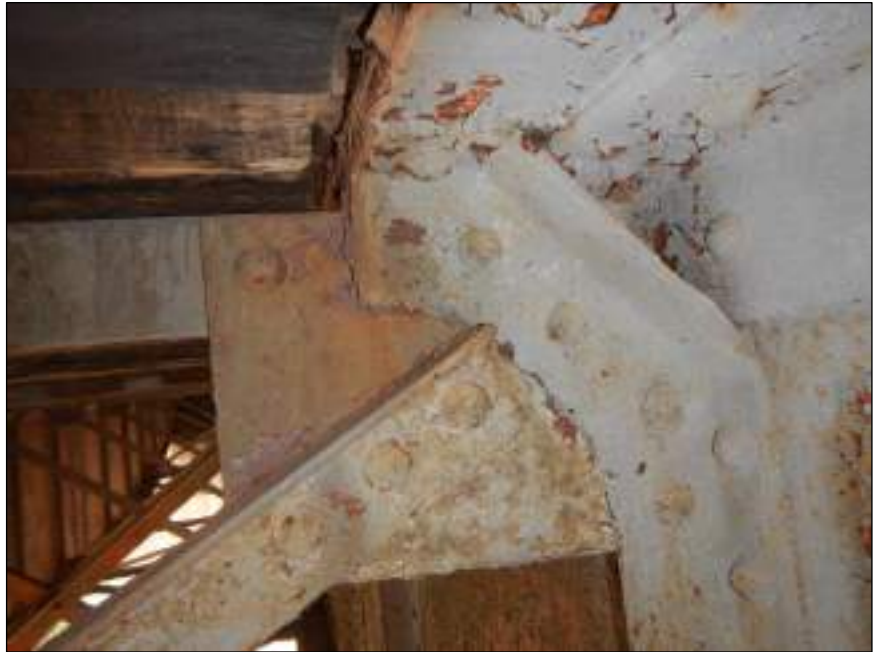
Photo 38:

General lower corner connection.

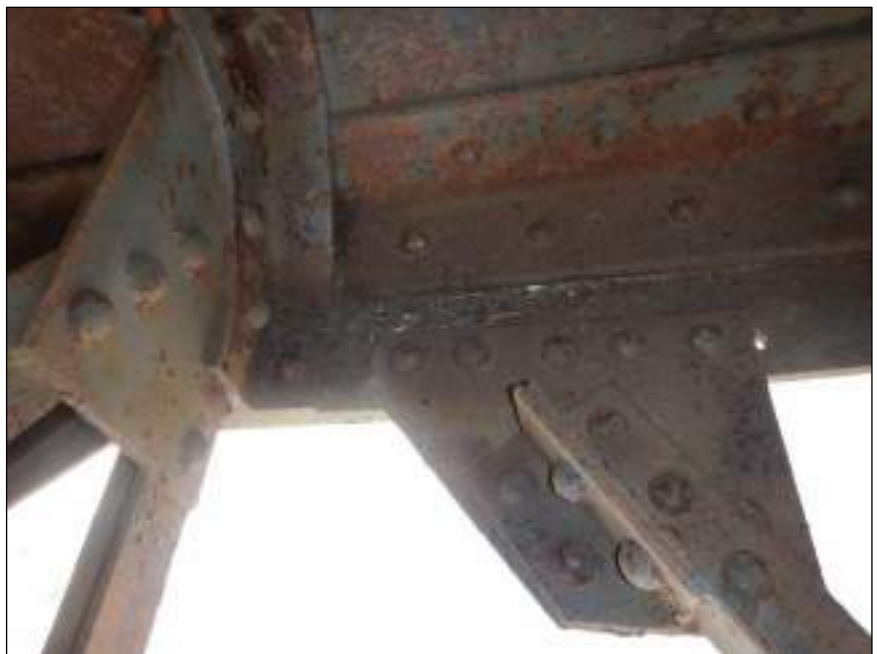
Photo 39:

Cross bracing center connection plate. Thickness reading location.

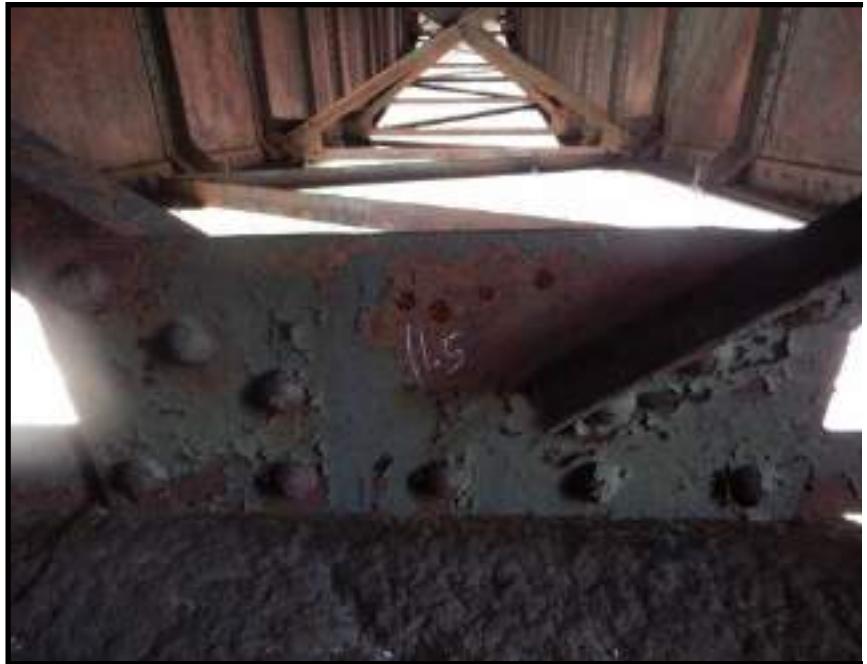
Photo 40:

Cross bracing corner connection plate. Thickness reading location.

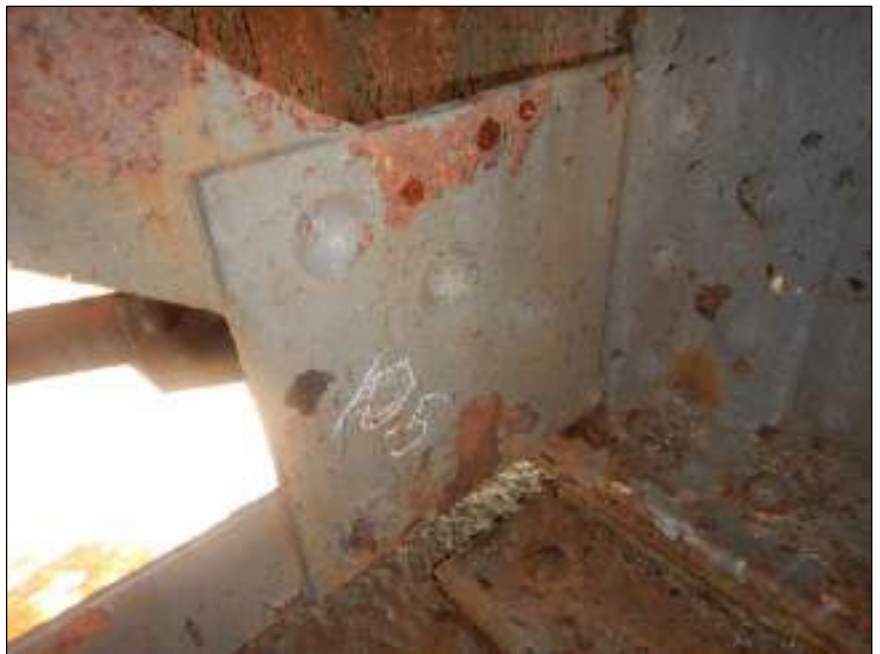
Photo 41:

Cross bracing. Thickness reading location.

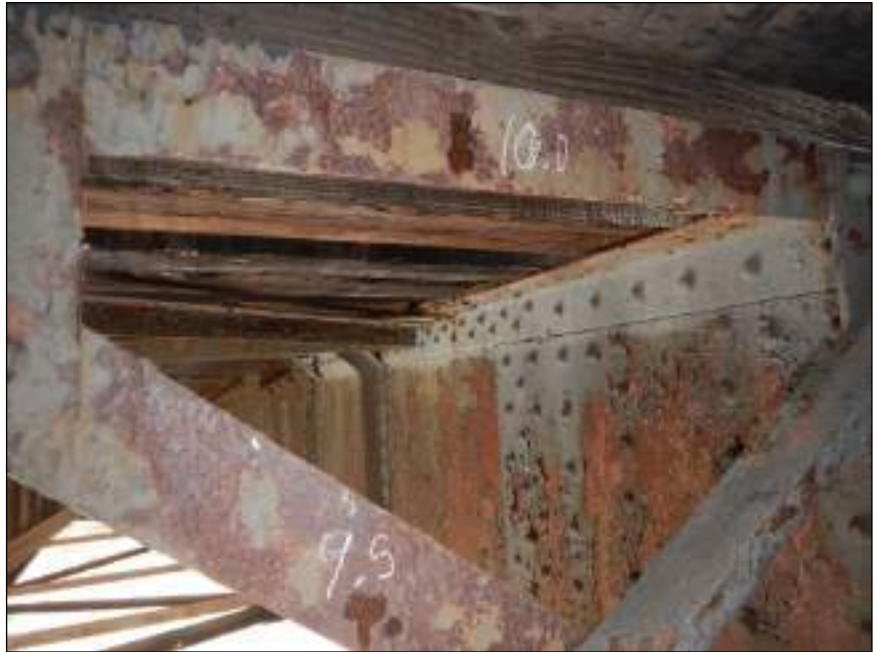
Photo 42:

Girder web stiffener thickness reading.

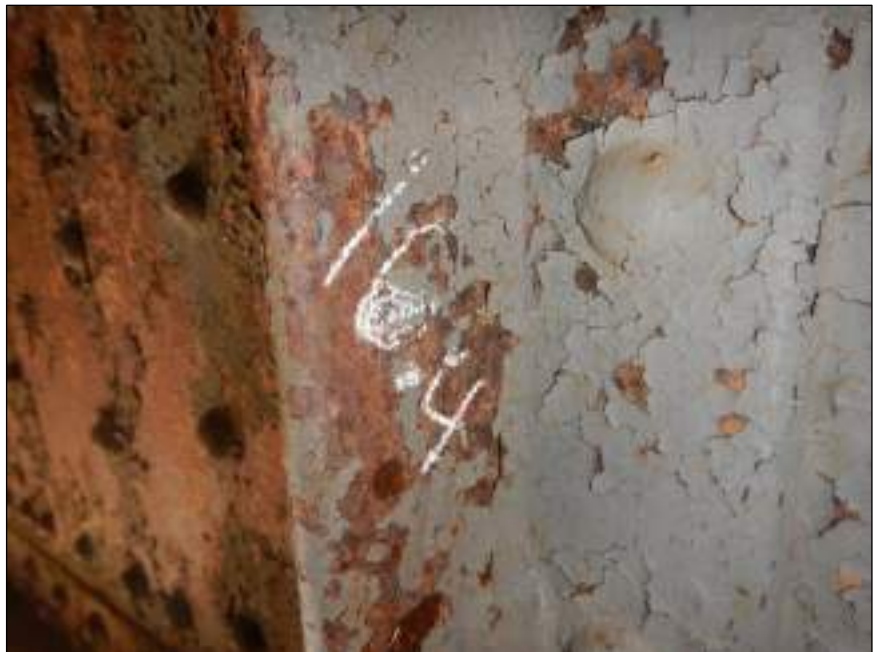
Photo 43:

Girder web thickness readings.

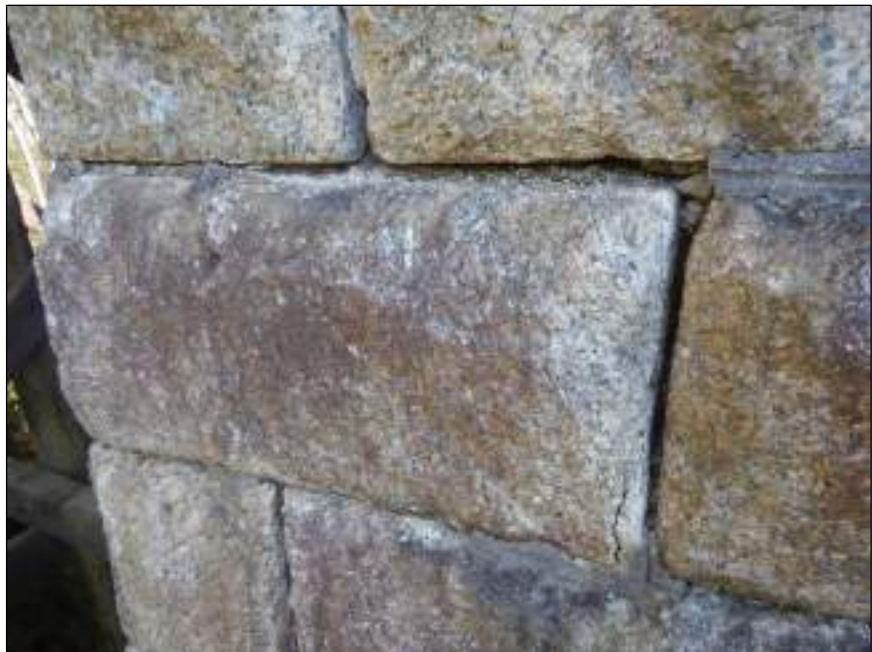
Photo 47:

Center pier South side. Cap has shifted.

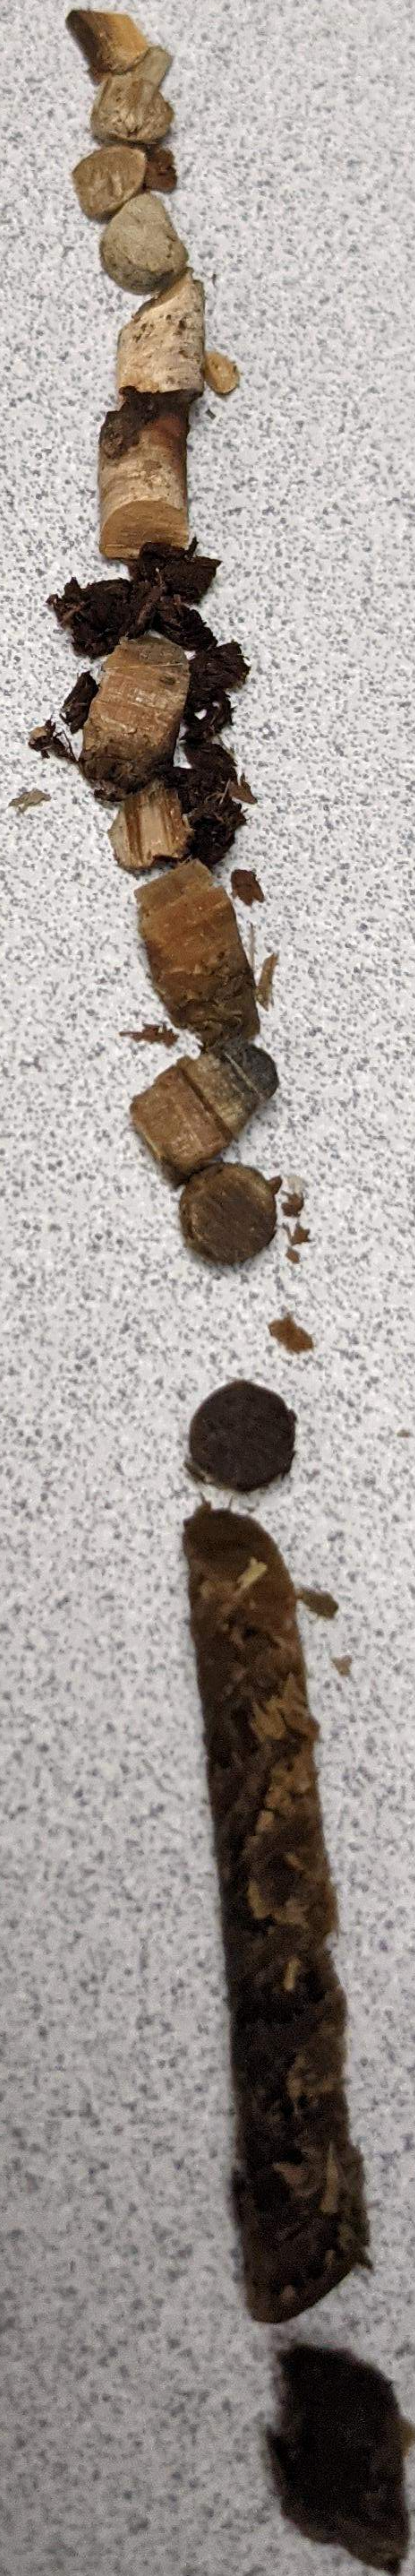
East Side
South Face
Bent 7 post-6
Core Sample
PIC

PHOTO 60:
CORE EXAMPLE OF ROTTEN POST

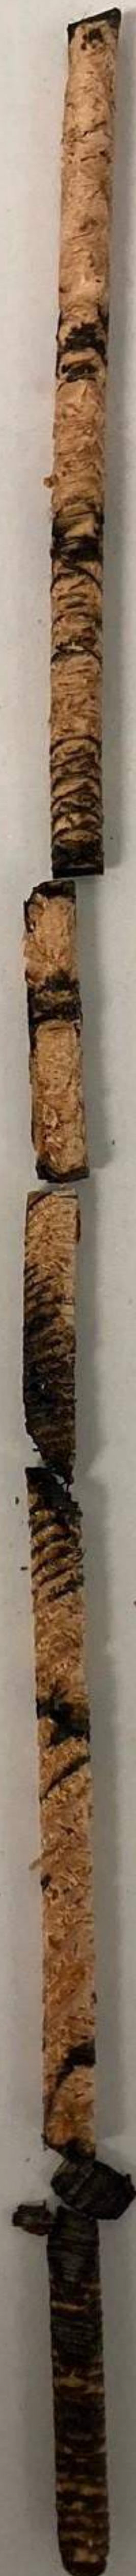
PHOTO: 63
TYPICAL RAILROAD
TIE SAMPLE

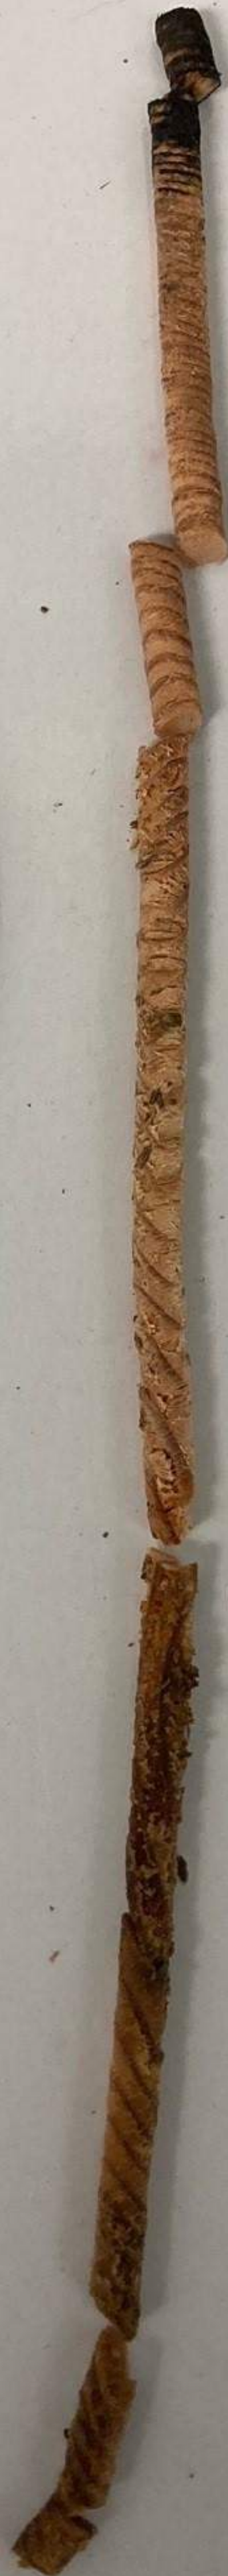
PHOTO: 64
TYPICAL RAILROAD
TIE SAMPLE
